PUBLIC NOTICE DETAILS

Application Number:	DA 2025/66
Application Type:	Discretionary Development Application
Property Location:	Marlborough Road, Miena (CT 243894/1)
Proposal:	Dwelling
Advertising Commencement Date:	16 February 2026
Representation Period Closing Date:	02 March 2026
Responsible Officer:	Louisa Brown, Senior Planning Officer

'Stone Hut & Split Rock' - Lot 1 Marlborough Rd, Miena 7030

BUSHFIRE HAZARD MANAGEMENT REPORT

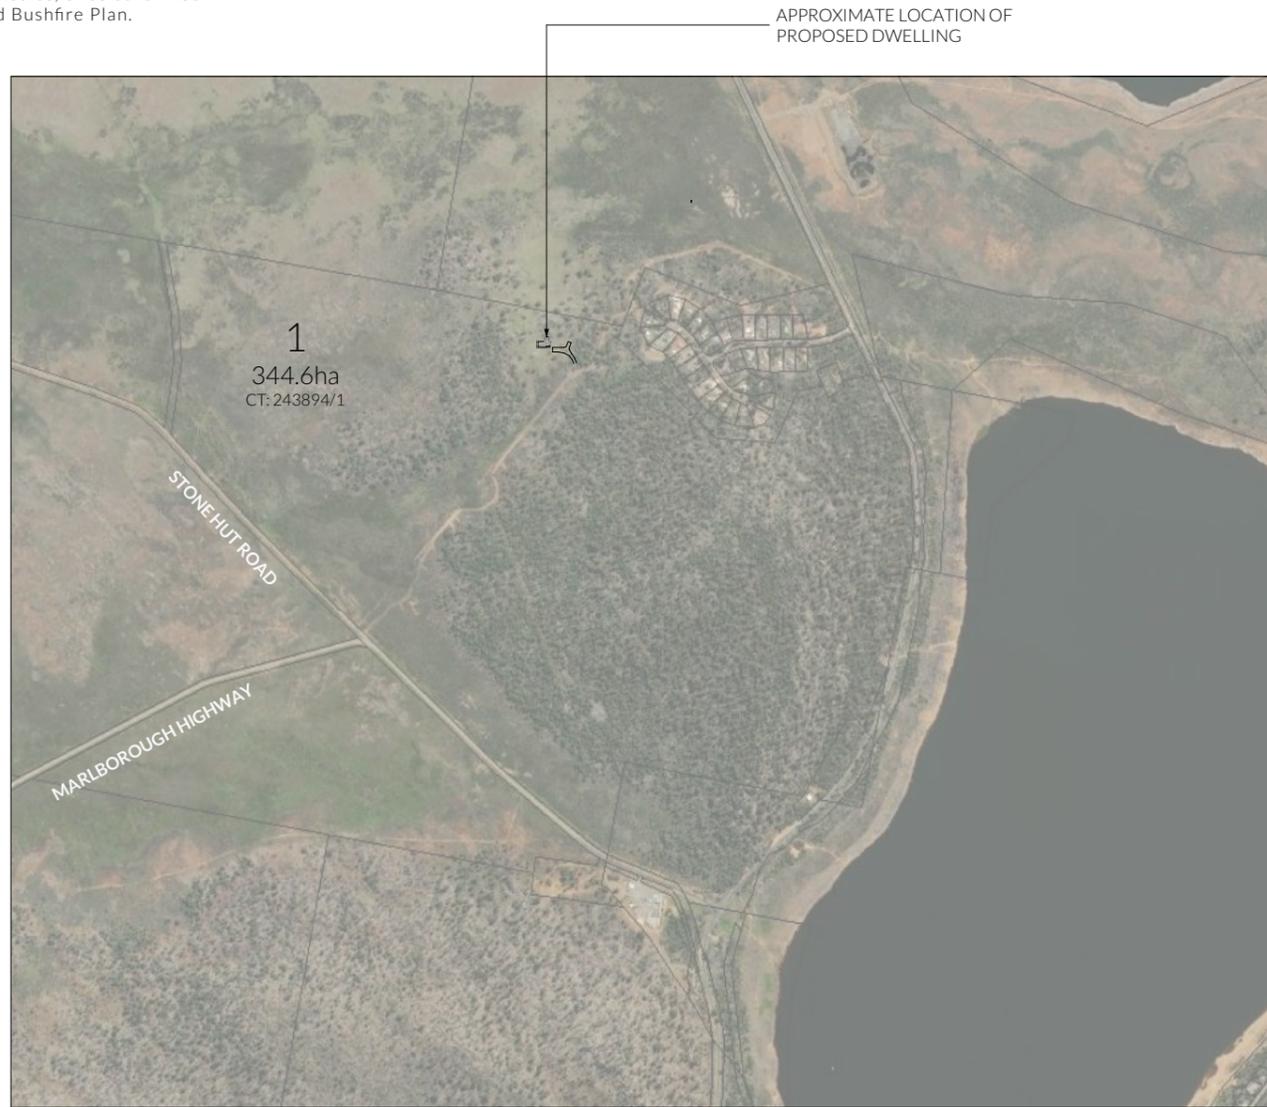
Location Plan

1:10000

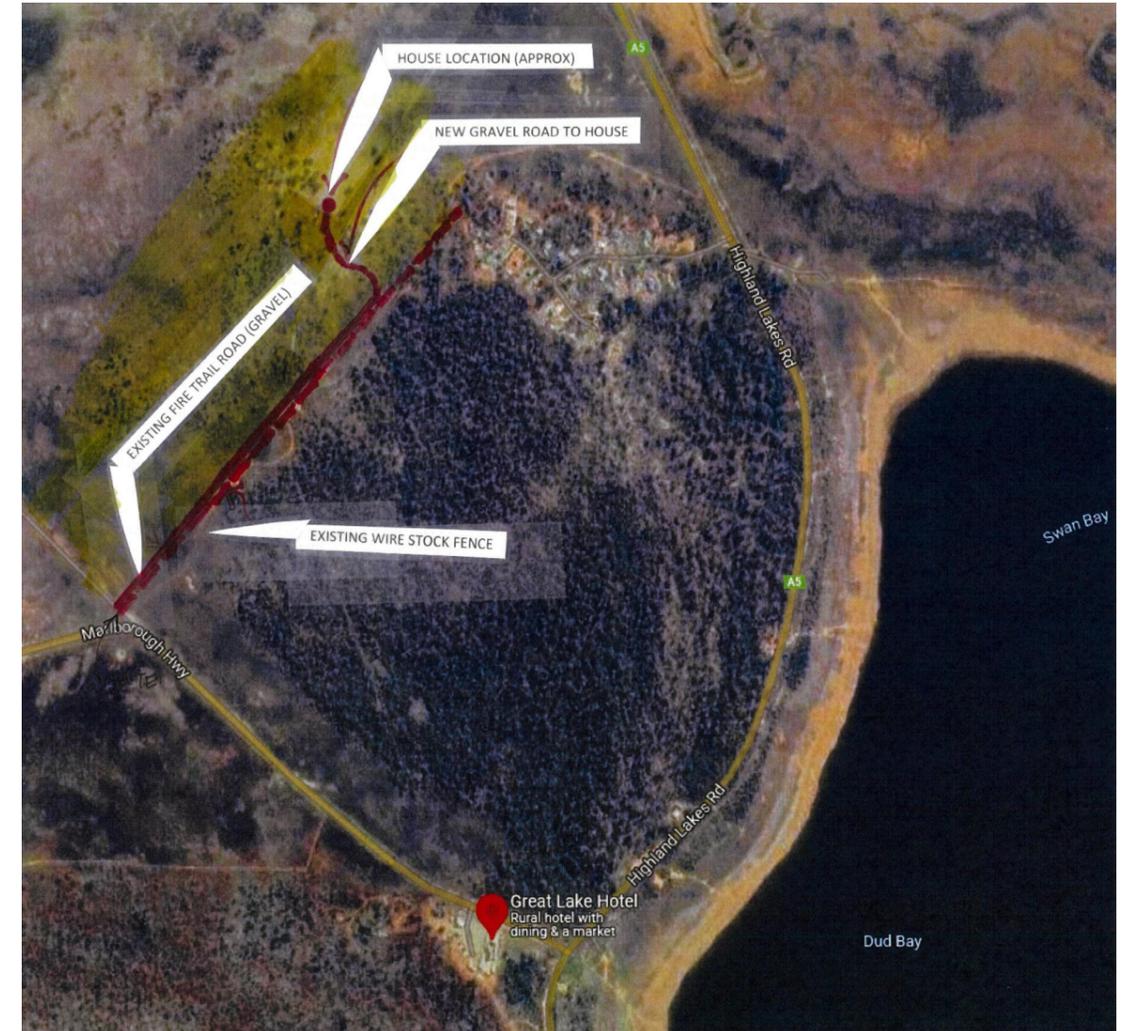
Notes from MCA Architects

Access through gate at Marlborough Highway intersection along fire trail road (break) left hand side of stock fence heading NorthEast at top of hill wind between rocks outcrops to house location on a new gravel farm road

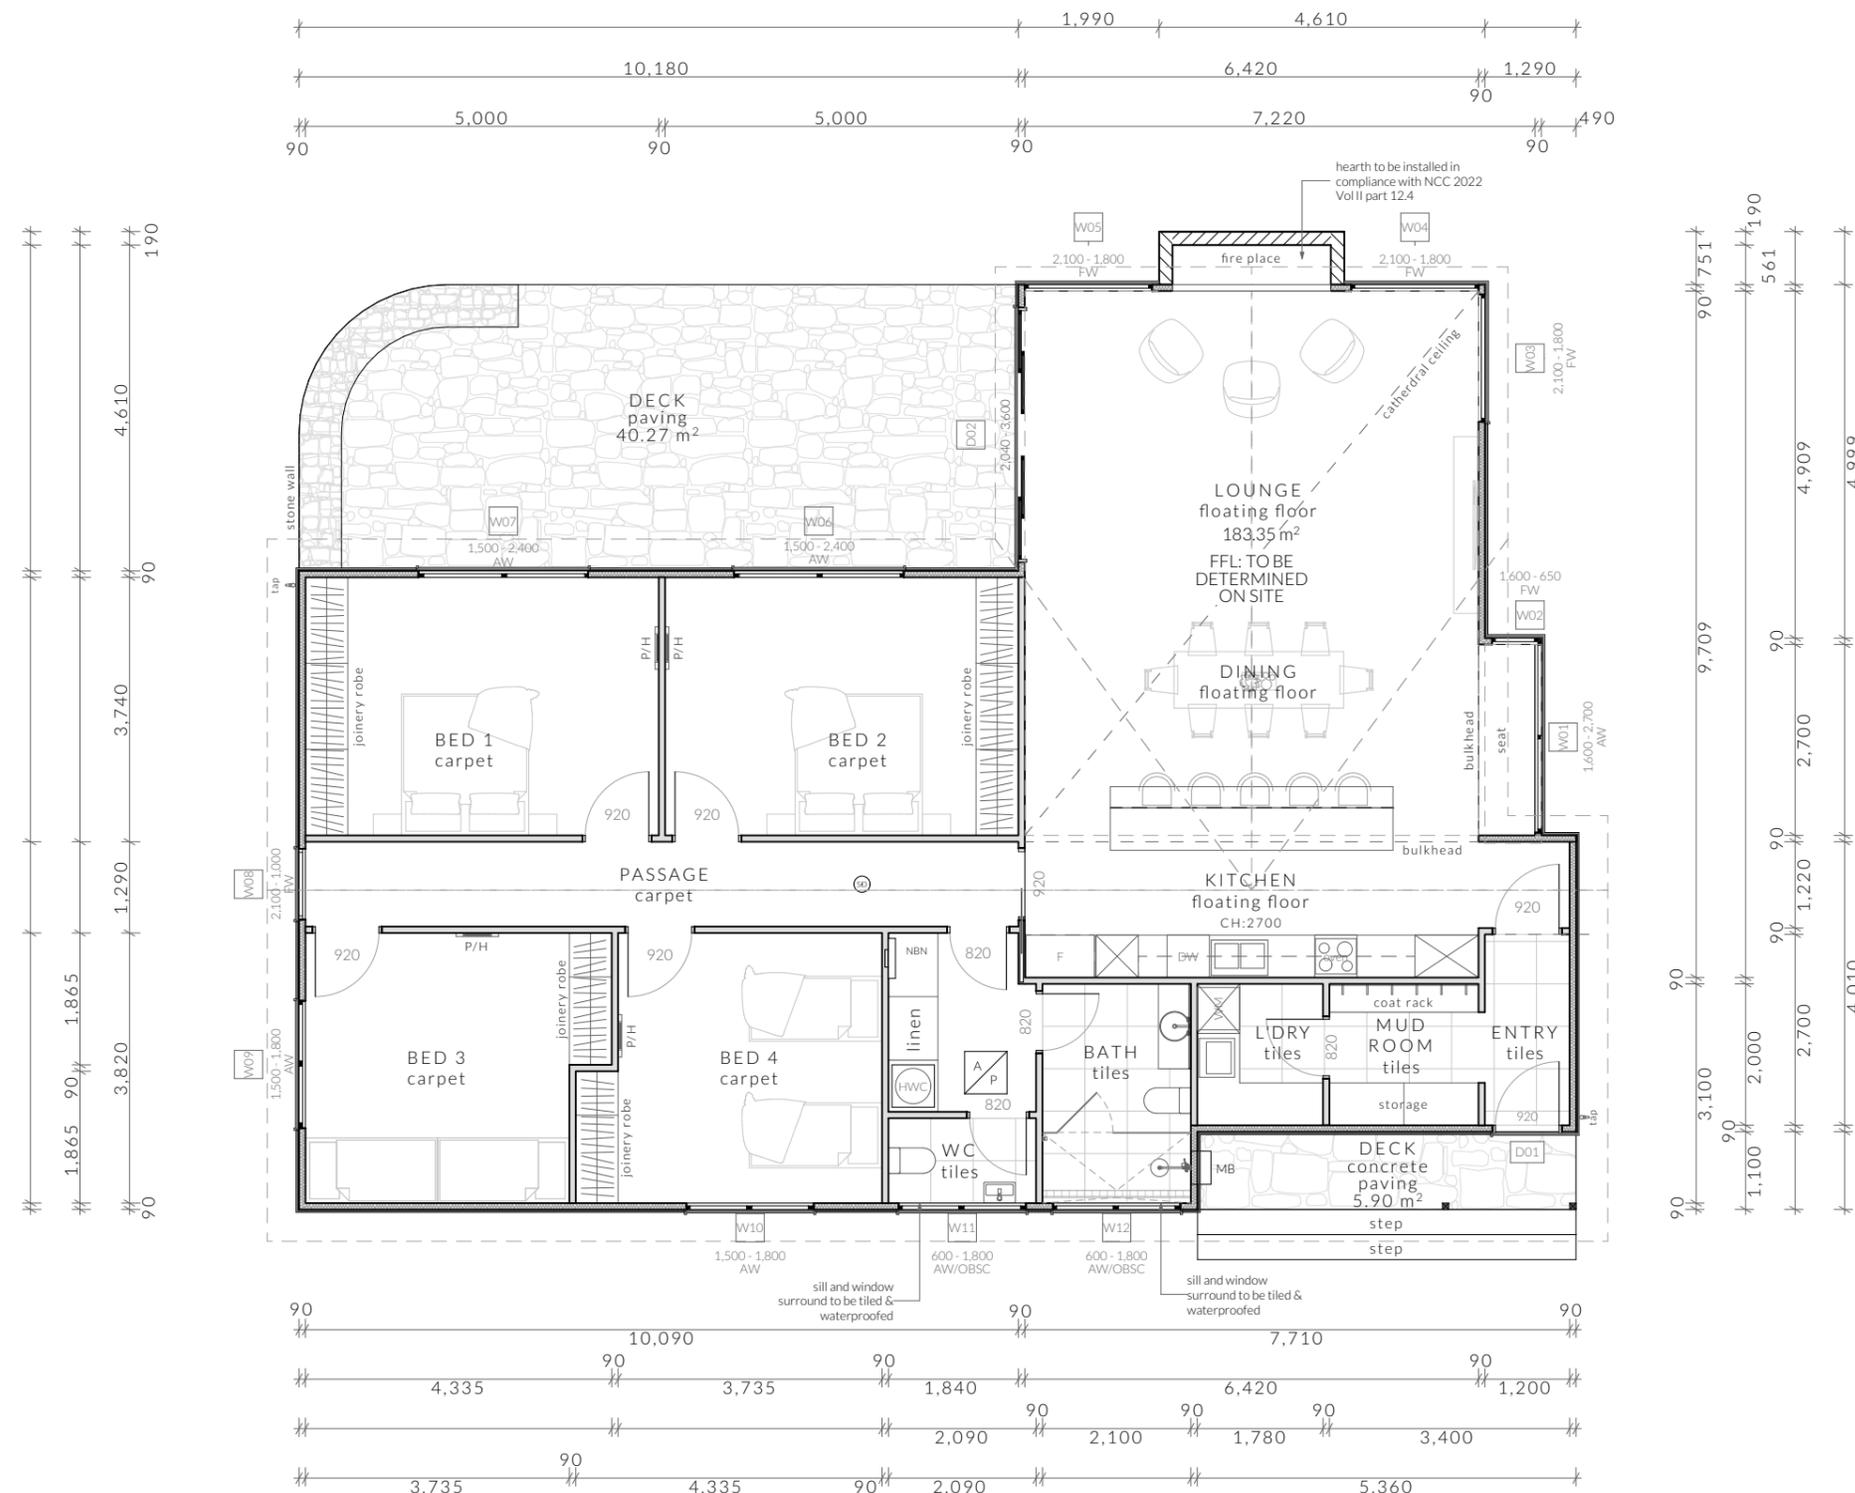
Total Floor Area 183.38m²
Deck 46.18m²

PINNACLE DRAFTING & DESIGN 7/3 Abernant Way, Cambridge 7170 03 6248 4218 admin@pinnacledrafting.com.au www.pinnacledrafting.com.au	Floor Plan Revision: DA - 01 Approved by: SJH/JRD	Scale: 1:100 @A3 Pg. No: A.03	Proposal: New Dwelling Client: James & Jessica Downie Address: 'Stone Hut & Split Rock' - Lot 1 Marlborough Rd, Miena 7030	Date: 14/11/2024 Drawn by: CJ Job No: 103-2022 Engineer: JMG Engineer Building Surveyor: TBA	<table border="1"> <thead> <tr> <th>Issue Date</th> <th>Description</th> </tr> </thead> <tbody> <tr> <td> </td> <td> </td> </tr> </tbody> </table>	Issue Date	Description				<p>These drawings are the property of Pinnacle Drafting & Design Pty Ltd. reproduction in whole or part is strictly forbidden without written consent. © 2023. These drawings are to be read in conjunction with all drawings and documentation by Engineers, Surveyors and any other consultants referred to within this drawing set as well as any CLC and/or permit documentation. DO NOT SCALE FROM DRAWINGS; All Contractors are to verify dimensions on site before commencing any orders, works or requesting/producing shop drawings. ANY AND ALL DISCREPANCIES DISCOVERED BY OUTSIDE PARTIES ARE TO BE BROUGHT TO THE ATTENTION OF THE PINNACLE DRAFTING & DESIGN PTY LTD.</p>	
	Issue Date	Description

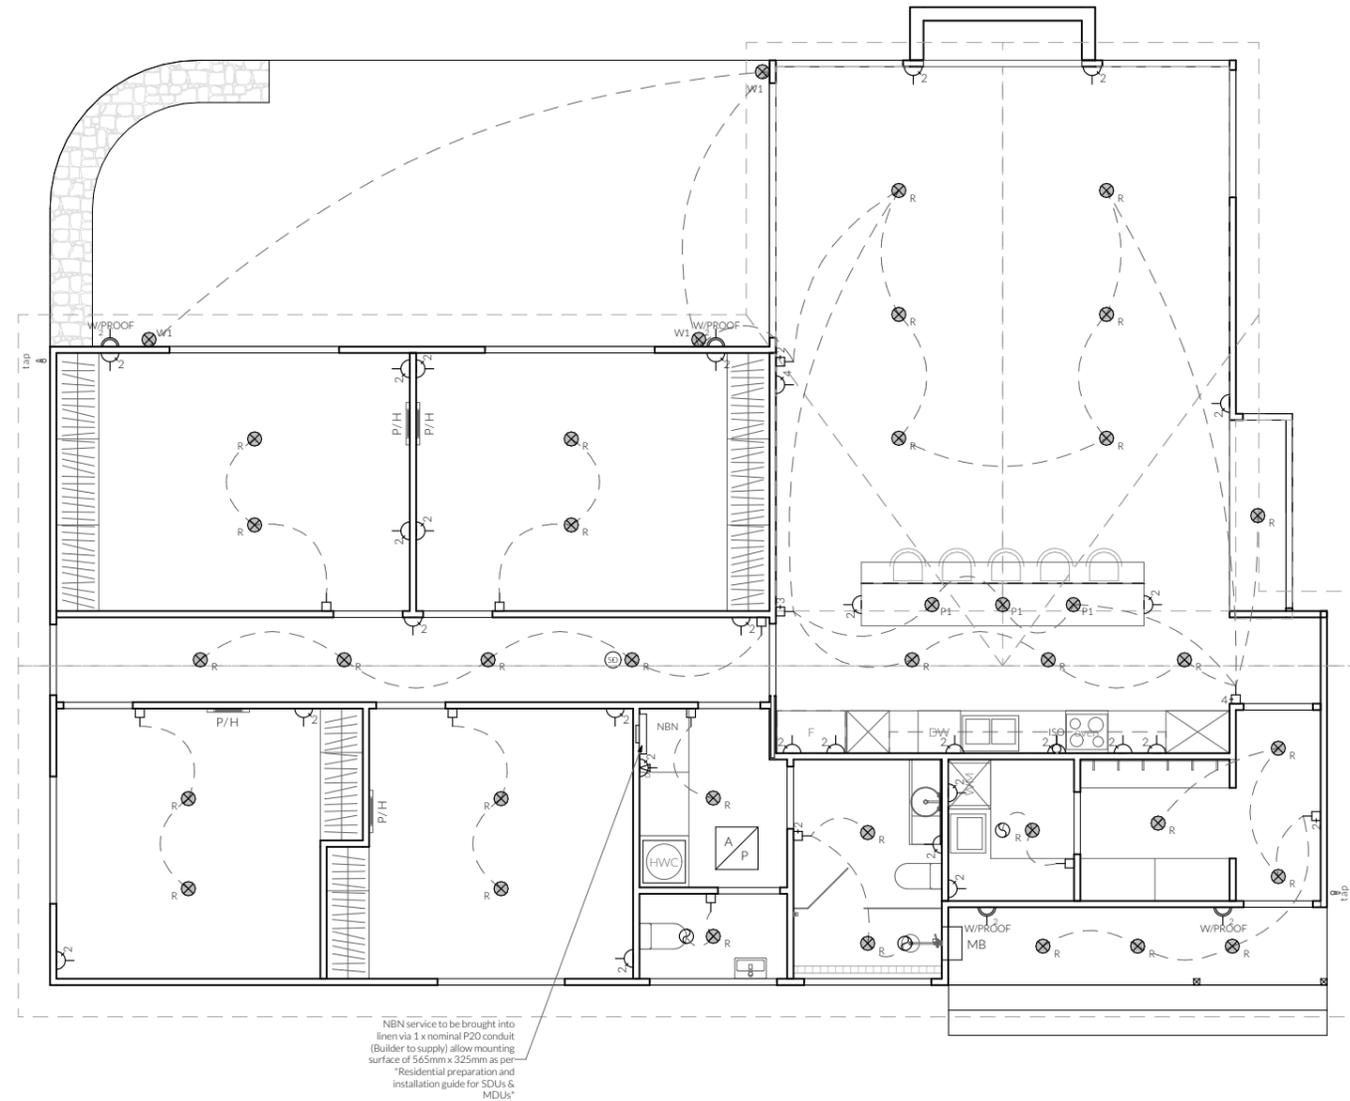
Electrical Plan - Lower

Symbol	Description	Allowance	Quantity
▽ ^D	DATA - CAT 6 (RJ45) - 1 GANG		1
⊙	FAN - CEILING - EXHAUST		3
2	GPO - (2) DOUBLE		27
ISO	GPO - (2) DOUBLE (WITH COOKTOP ISOLATOR SWITCH)		1
W/PROOF	GPO - WEATHER PROOF DOUBLE		4
⊗ _R	LIGHT - CEILING - DOWNLIGHT RECESSED	10W	33
⊗ _{P1}	LIGHT - CEILING - PENDANT - TYPE 1	10W	3
⊗ _{W1}	LIGHT - WALL MOUNTED - TYPE 1	10W	3
⊥	SWITCH - LIGHT 1 GANG		10
2 ⊥	SWITCH - LIGHT 2 GANG		1
3 ⊥	SWITCH - LIGHT 3 GANG		2

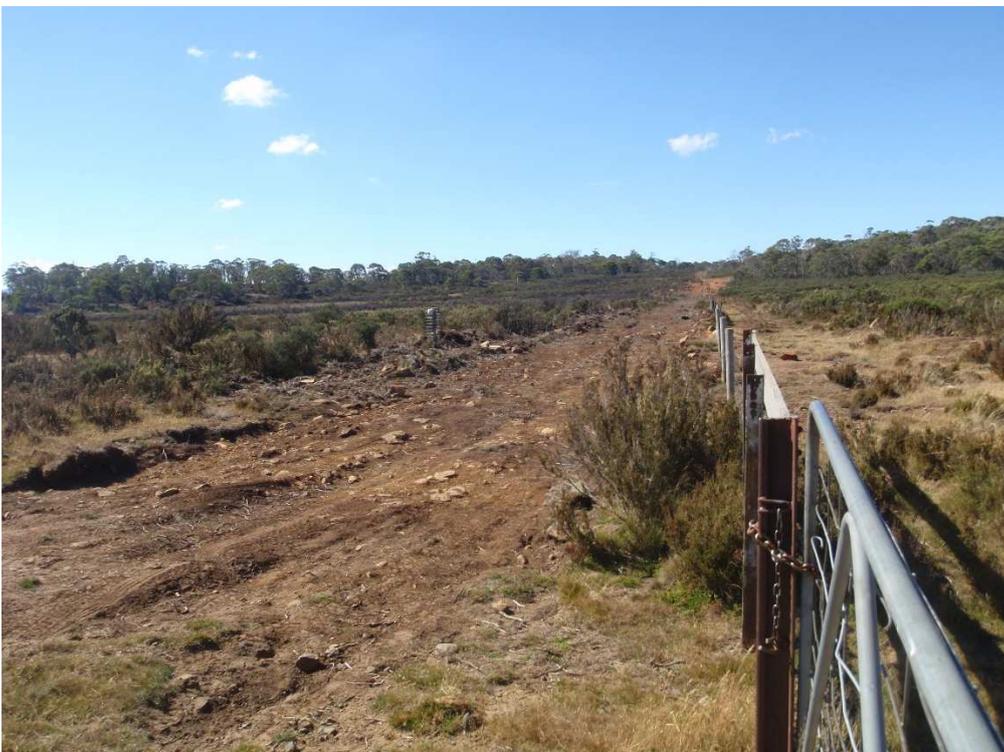
**PIC 4: EXISTING FIRE TRAIL LEADING TO PROPOSED BUILDING SITE.
FIRE TRAIL TO BE FORMED INTO COMPLIANT ALL-WEATHER SITE ACCESS**

The proposed house is to be accessed from Marlborough Rd via a proposed 1km all-weather gravel driveway. The proposed driveway will comply with the requirements of the *Bushfire Determination, Part 4.2: Property Access, Table 4.2: Requirements for Property Access, Part C*. Refer Appendix 1: Bushfire Hazard Management Plan.

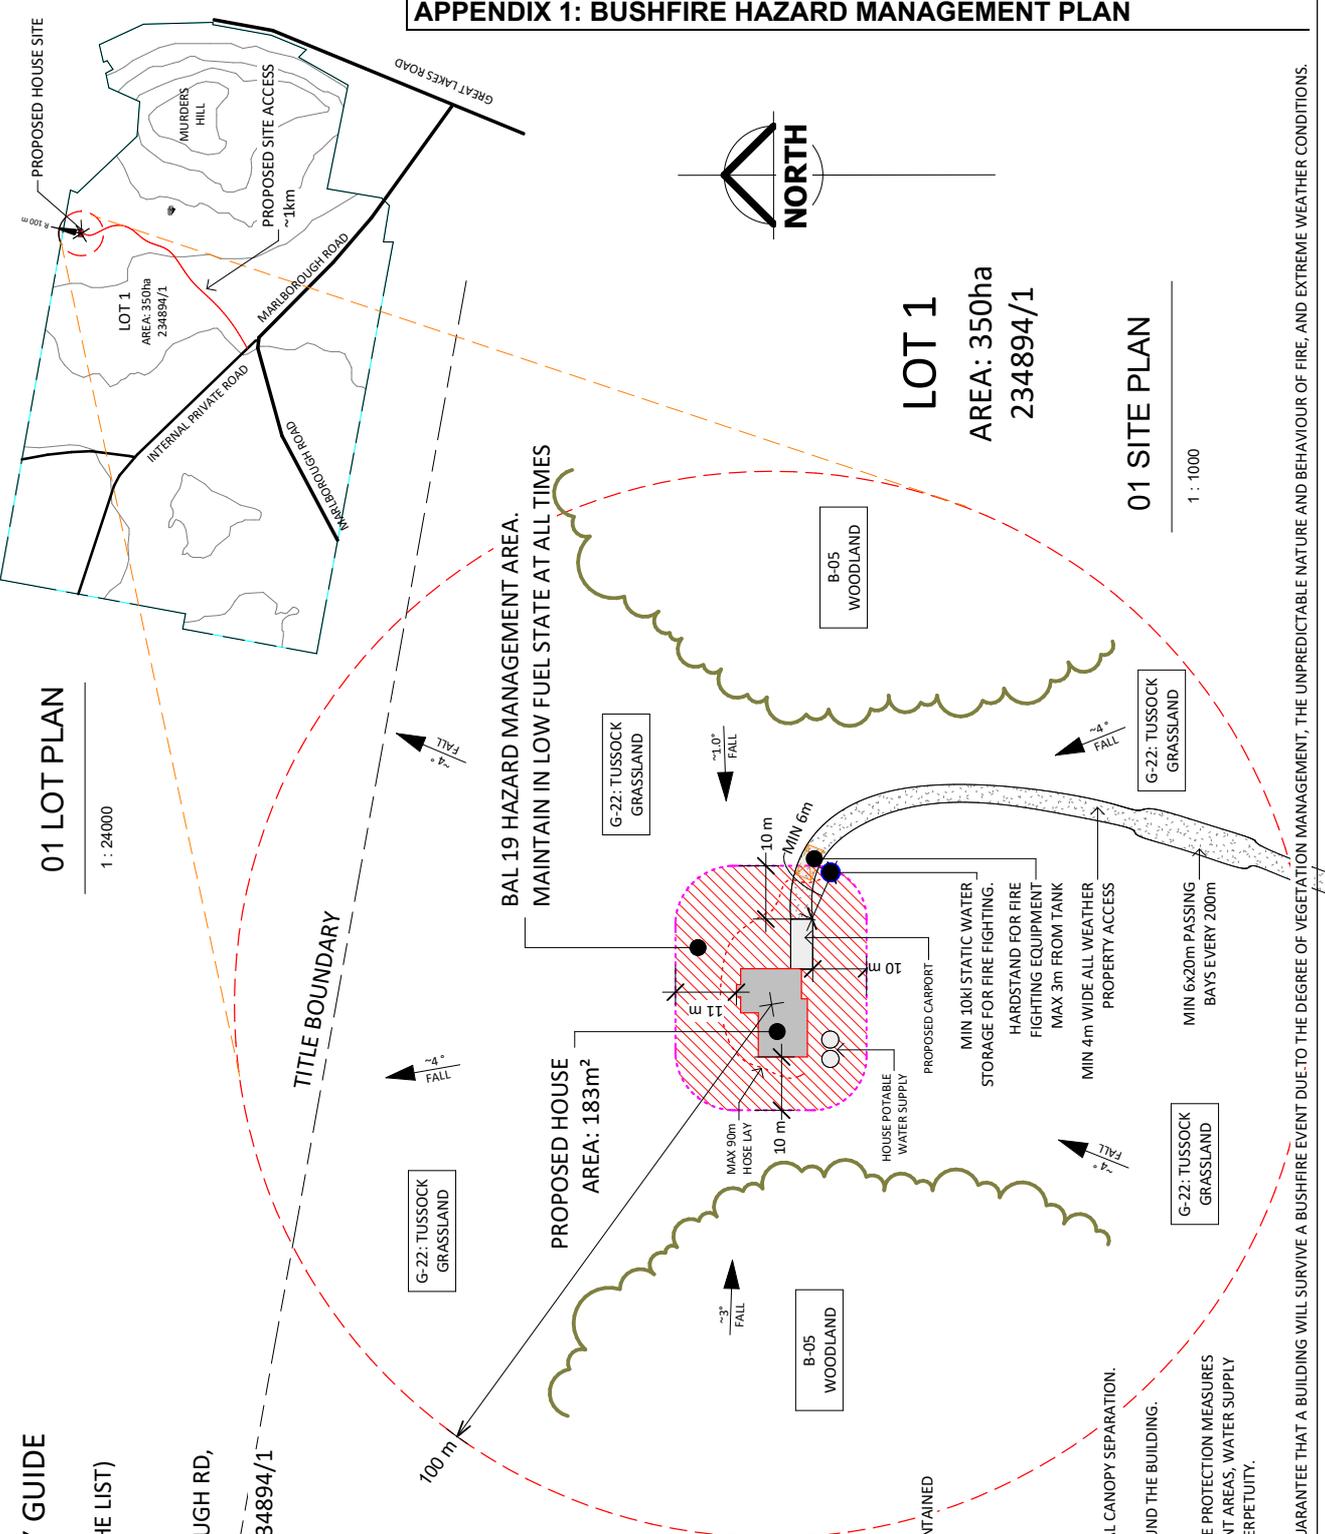
01 LOT PLAN
1 : 24000

BUILDING CONSTRUCTION
BUILDINGS TO BE BUILT IN TO A BAL 19 CONSTRUCTION STANDARD IN ACCORDANCE WITH THE NATIONAL CONSTRUCTION CODE OF AUSTRALIA AND AS3959:2018 PART 3 & 6.

WATER SUPPLY
PROVIDE MIN 10KL STATIC WATER SUPPLY COMPLIANT W/ DIRECTOR OF BUILDING CONTROL DETERMINATION: REQUIREMENTS FOR BUILDING IN BUSHFIRE-PRONE AREAS V2.2, MARCH 16, 2020, PART 4.3: WATER SUPPLY, TABLE 4.2B: REQUIREMENTS FOR STATIC WATER SUPPLY FOR FIREFIGHTING, PARTS A-E. REFER BUSHFIRE HAZARD MANAGEMENT PLAN FOR LOCATION.

HAZARD MANAGEMENT AREA
BAL 19 HAZARD MANAGEMENT AREA SHOWN HATCHED TO BE MANAGED AND MAINTAINED IN A MINIMUM FUEL STATE AT ALL TIMES. REFER MAINTENANCE SCHEDULE BELOW.

Given the size of the Lot and the setback from the nearest boundary, there is ample scope to reduce the BAL to BAL 19 by increasing the Hazard Management Area (HMA). As per *AS3959:2018, Table 2.6*, to achieve a BAL 19 HMA, a minimum 5° downslope distance of 11m is the required separation from the surrounding native grasses. As this is the worst-case slope associated with the building site, and the proposed dwelling is to have a 10m buffer on all sides, a BAL 19 HMA can be applied wholly within the boundaries of the subject lot and is legally able to be managed and maintained in a low fuel state by the title holder. As such, the requirements of the *Bushfire Determination Part 4.4: Hazard Management Areas, Table 4.4: Requirements for Hazard Management Areas, Part B (a)&(b)* are met with the implementation of a BAL 19 HMA. Refer Appendix 1: Bushfire Hazard Management Plan.

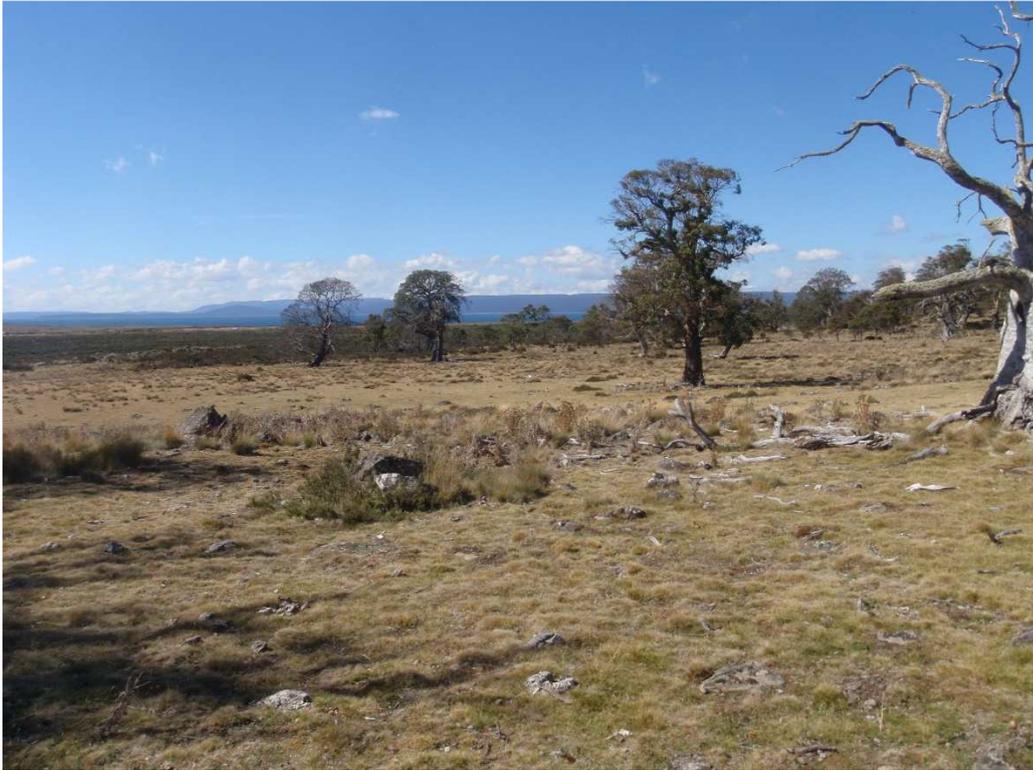
PIC 9: DISTRICT VIEW TO THE NOR'EAST SHOWING TYPICAL GRASSLAND VEGETATION

The subject site attracts a raw BAL 29 rating, as per *AS3959:2018 Table 2.6*, due to the proximity of native tussock grasses surrounding the proposed dwelling site in all directions. This vegetation is classified 'G-22: Tussock Grassland' under *AS3959:2018, Part 2.2.3, Table 2.3*. Between the proposed house and the hazard vegetation, an area of low threat vegetation and non-vegetated areas is proposed as buffer to the hazard vegetation, extending for 10m in all directions. This vegetation is excluded under *AS3959:2018 Part 2.2.3.2 (e) & (f)*.

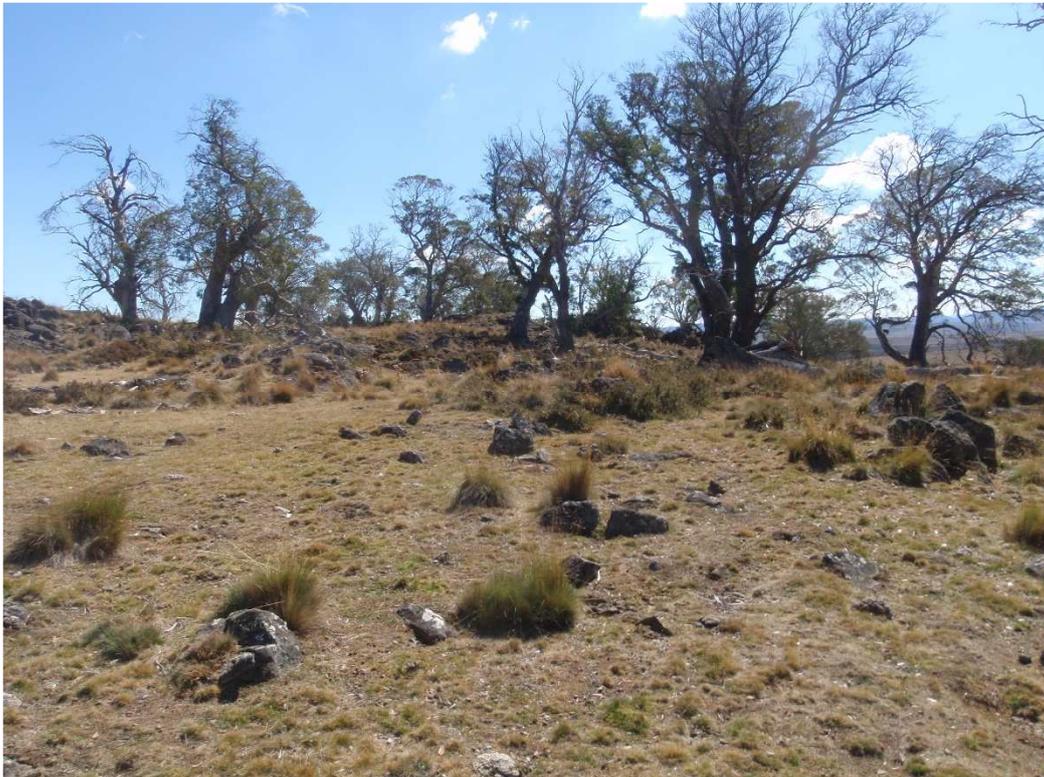
PIC 10: DISTRICT VIEW TO THE SOU'WEST SHOWING TYPICAL GRASSLAND & WOODLAND VEGETATION ON THE RISES.

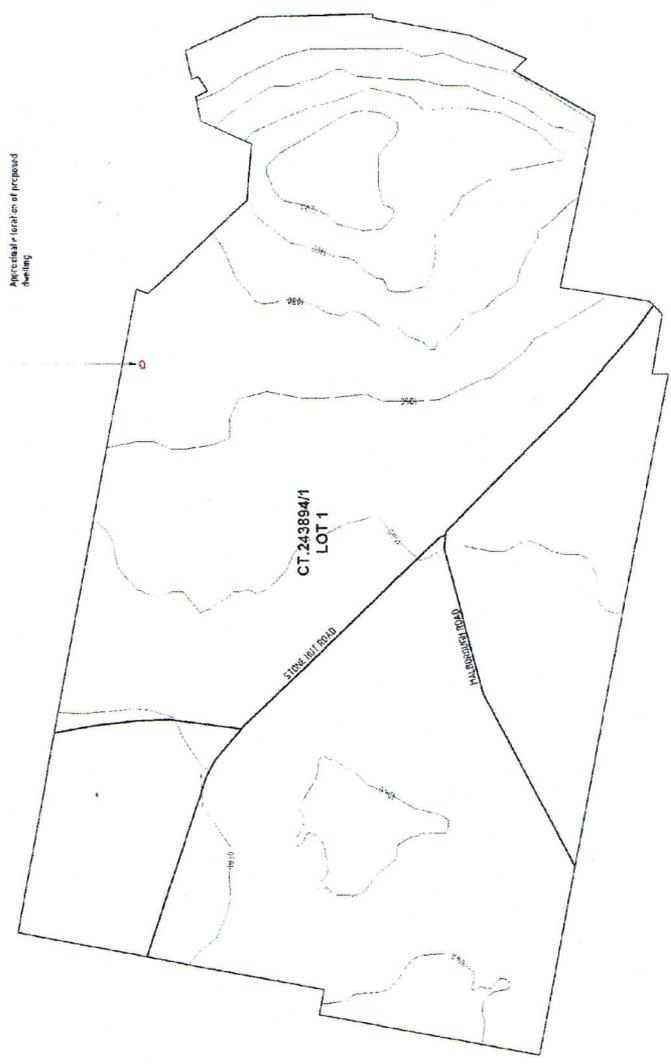
SITE PLAN 1: 10000
CONTOUR INTERVAL: 20 ft.

Approximate location of proposed dwelling

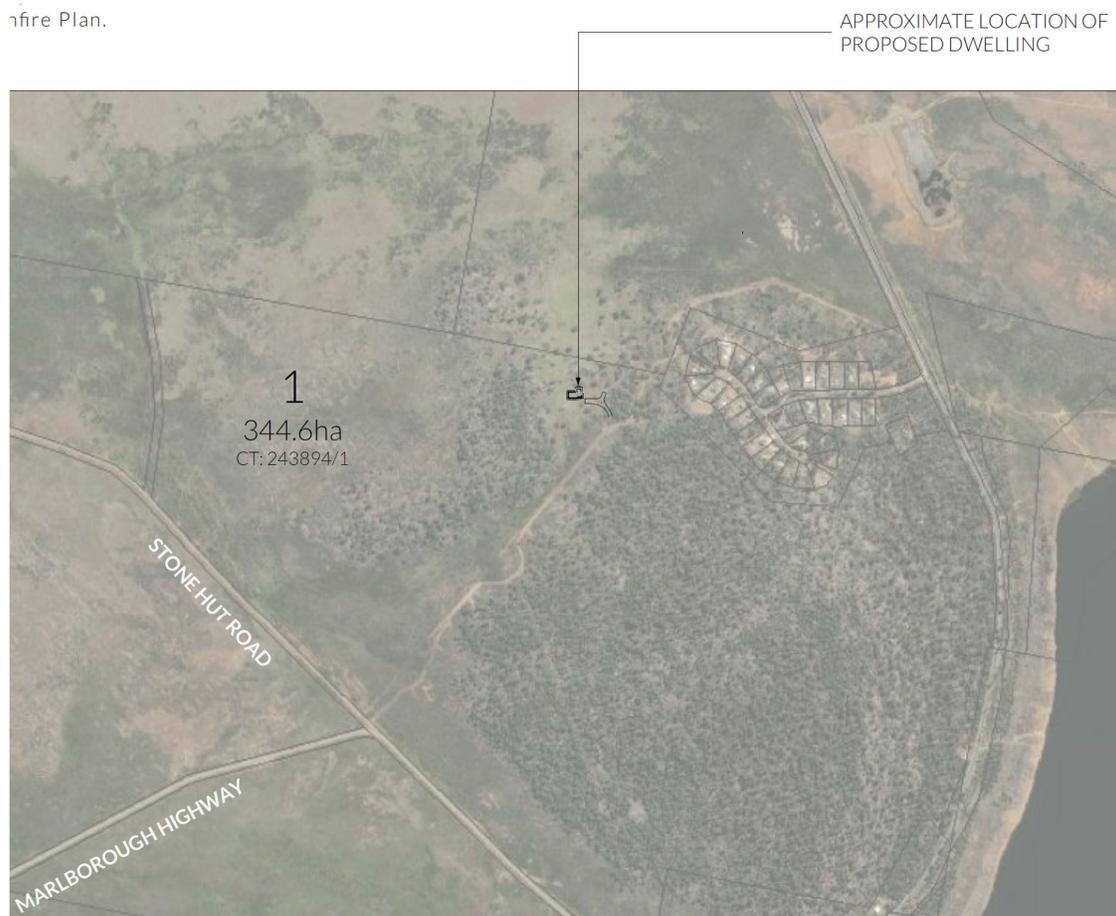
Figure 1. Location of the proposed dwelling

The Development is the construction and use of a dwelling and access road, with the establishment and maintenance of a bushfire hazard management area (BHMA) on the property Stone Hut in the Central Highlands (Figure 1).
