# PLANNING PERMIT APPLICATION

Proposed TasGRN telecommunication works at:

Existing Communications  
compound, Mount King William 1,  
Franklin-Gordon Wild Rivers National Park

**Tasmanian Government Radio  
Network**

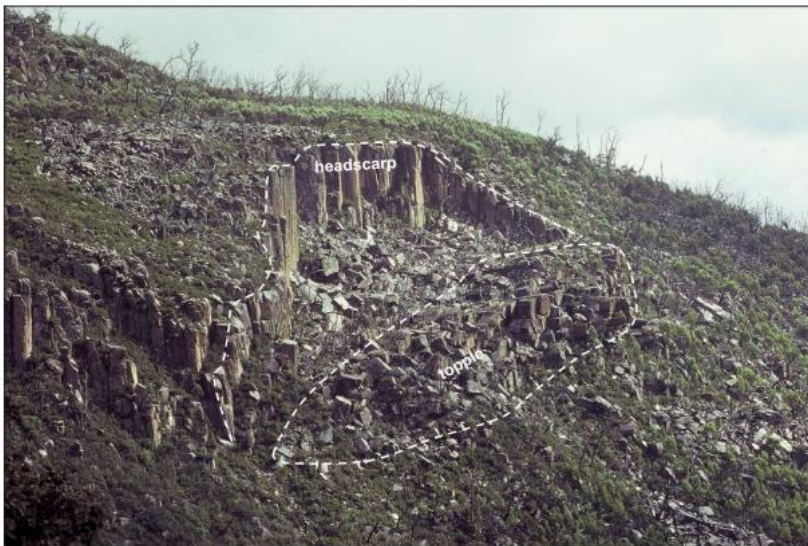
A typical block topple landscape within Dolerite is shown within Figure 3-1, this formation and aftermath are visible throughout Mount King William project site.

Figure 3-1: Rock toppling landscape (Mazengarb & Stevenson, 2010)
