Application Number:	DA 2026/20
Application Type:	Discretionary Development Application
Property Location:	473 Rockmount Road, Ellendale
Proposal:	Outbuilding
Advertising Commencement Date:	18 March 2026
Representation Period Closing Date:	01 April 2026
Responsible Officer:	Louisa Brown, Senior Planning Officer

**PROPOSED COLORBOND SHED
 (20m x 10m)**

**473 ROCKMOUNT RD,
 ELLENDALE, TAS - 7140**

INTRODUCTION

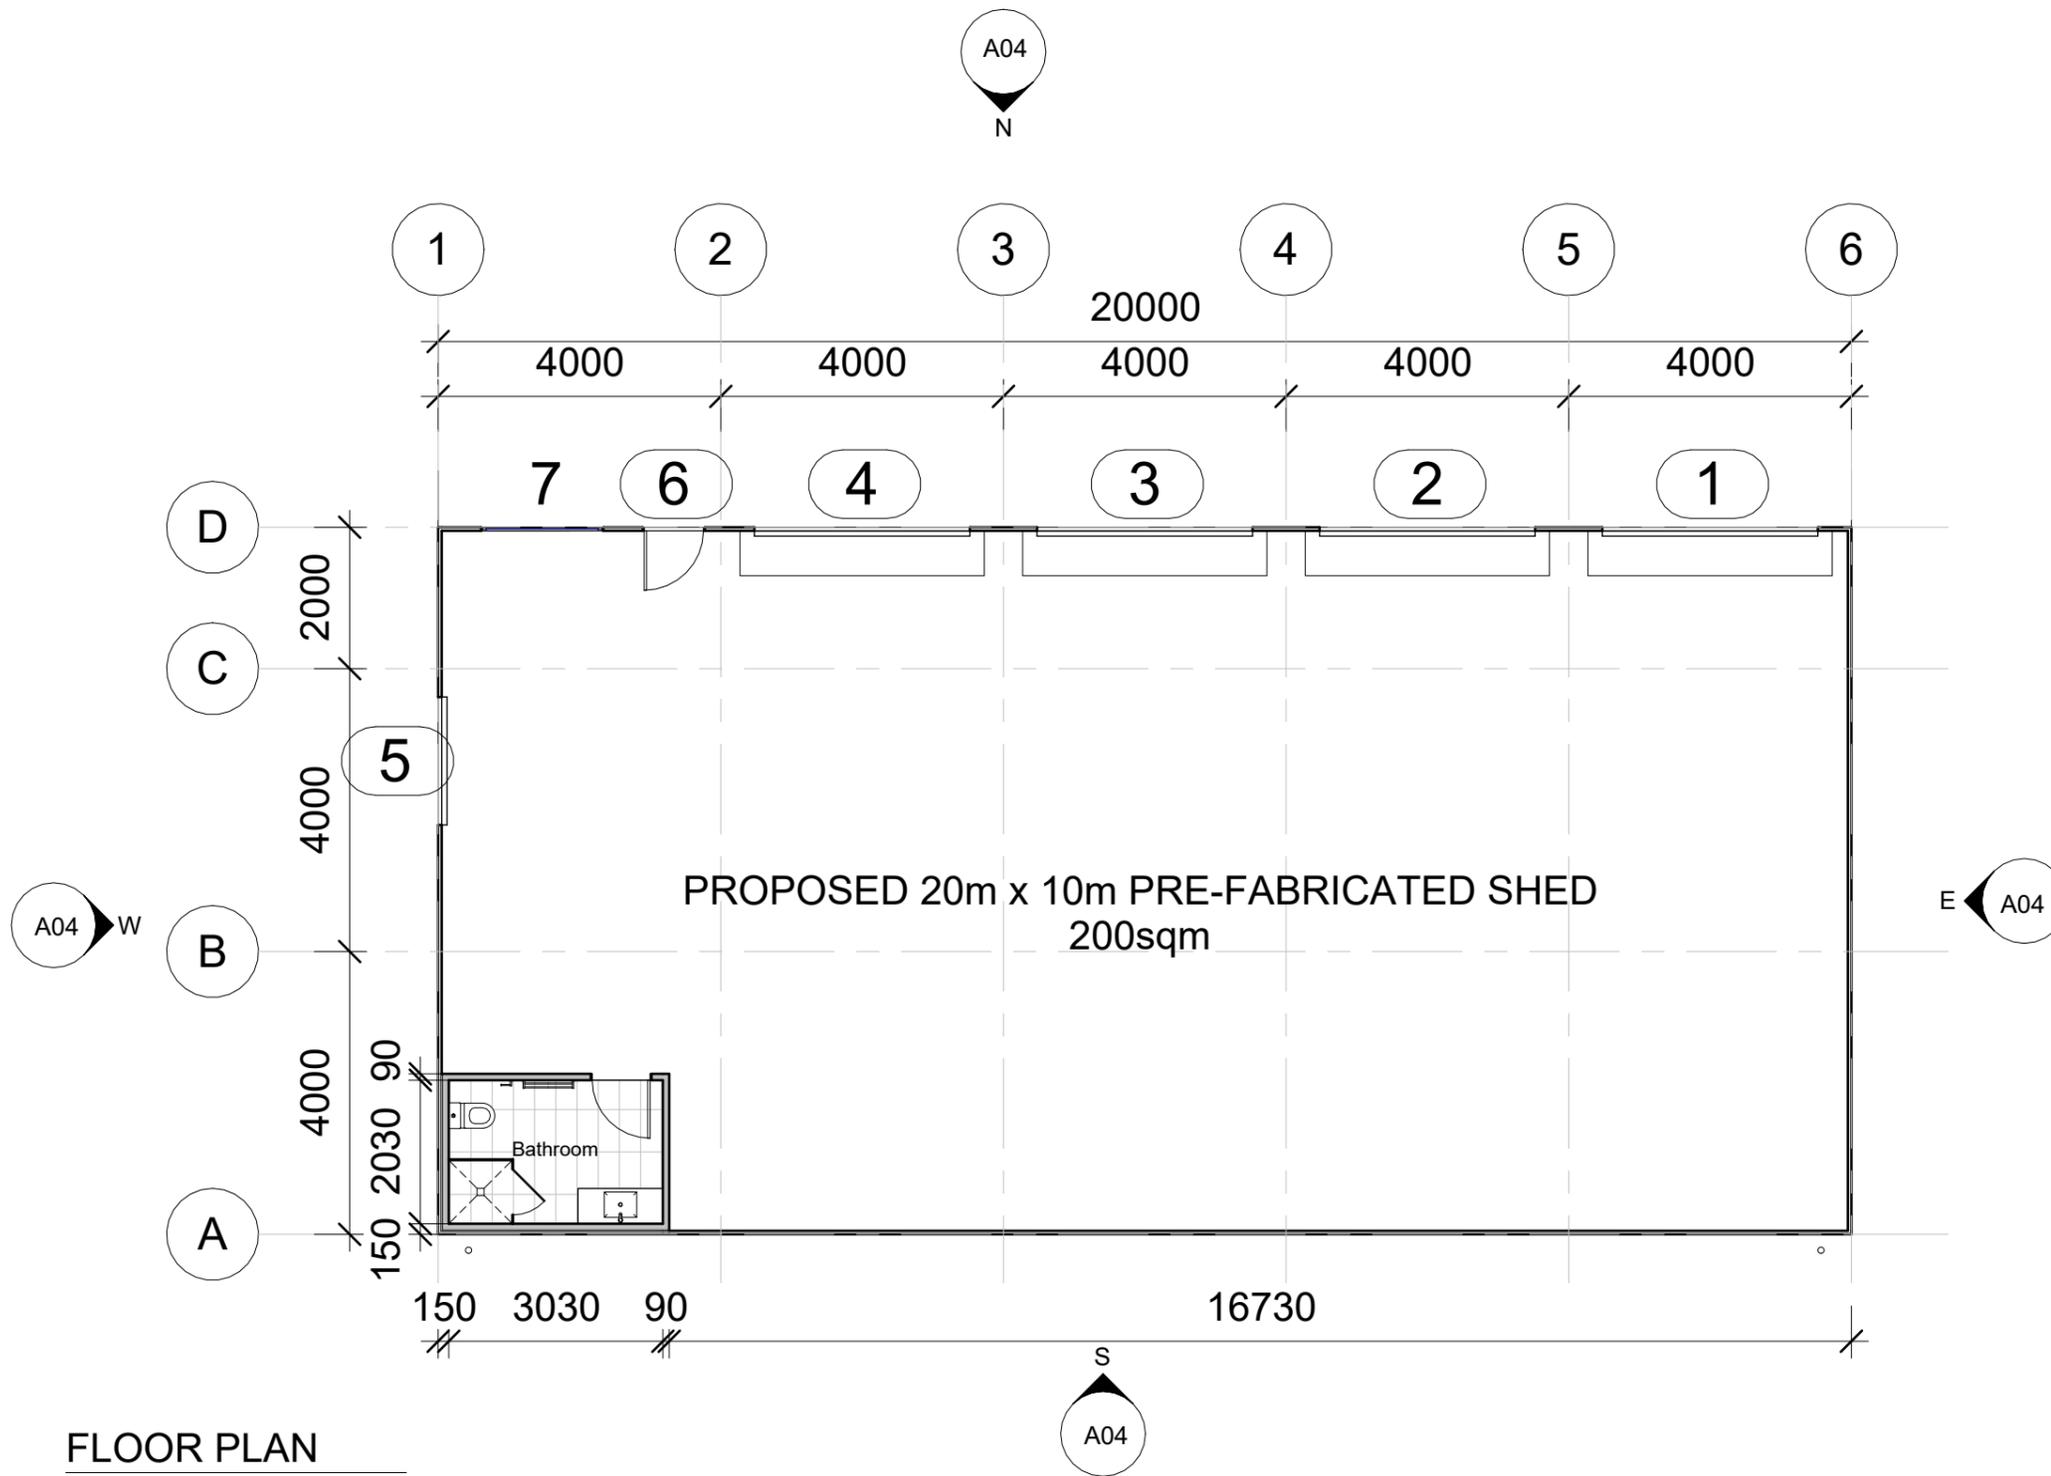
Sheet: FLOOR PLAN		
Drawn: GK		
Scale: 1 : 100	Size: A3	Date: 16/10/2025
Project: 473RRE/TAS/ARCH-2025	Sheet: A03	Rev:

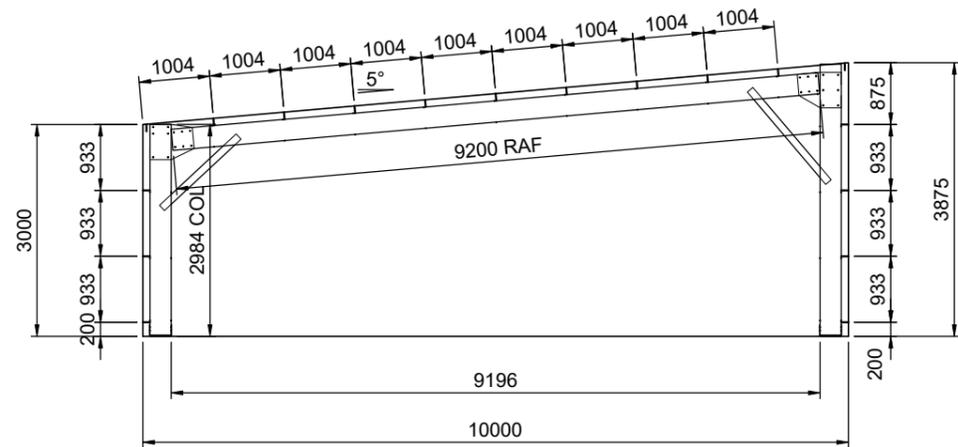
5 INTERNAL FRAMING ELEVATION
2 SCALE: 1:100

FRAMES 2-5

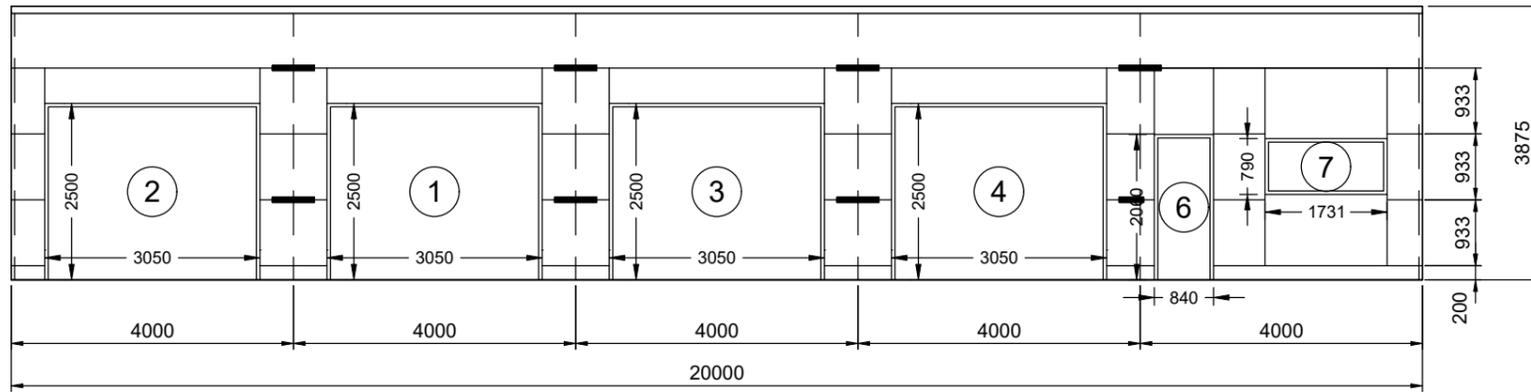
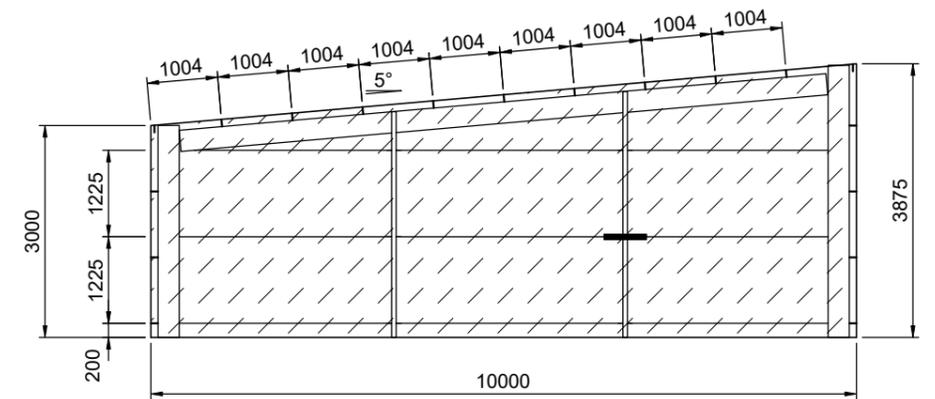
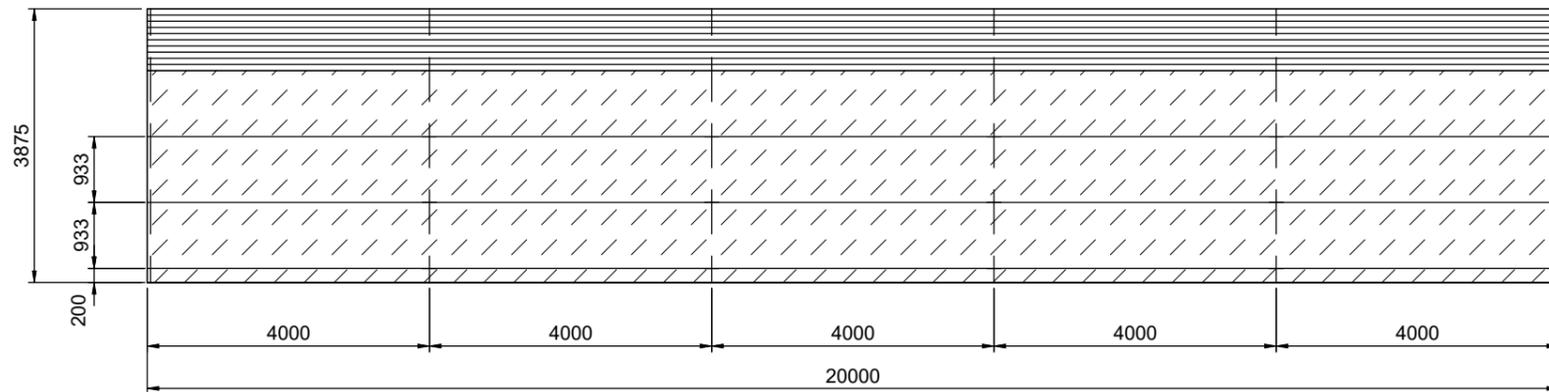
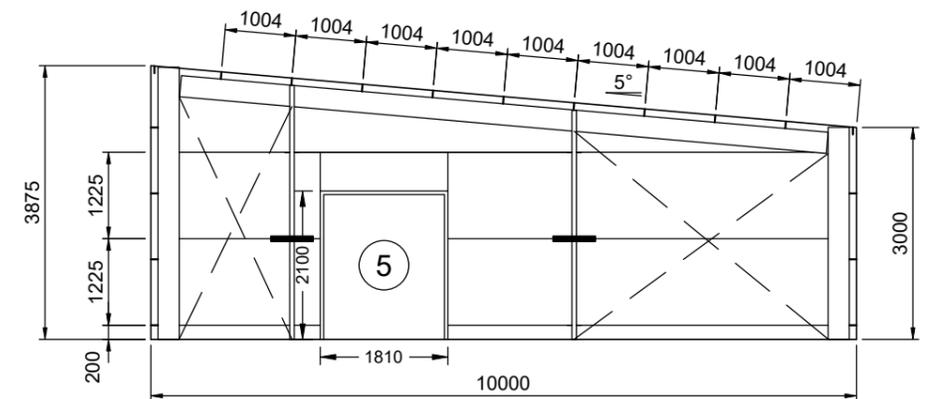
2 SIDEWALL B FRAMING ELEVATION
3 SCALE: 1:100

3 REAR FRAMING ELEVATION
3 SCALE: 1:100 FRAME #6

DIAPHRAGM SCHEDULE
 SHEETING IN DIAPHRAGM SECTIONS (SHOWN AS HATCHED AREA ON ELEVATIONS) NOT TO BE CUT UNDER ANY CIRCUMSTANCES

WALL	DISTANCE FROM WALL EDGE
Sidewall 'A'	0-20000
Endwall 'B'	0-10000

1 SIDEWALL A FRAMING ELEVATION
3 SCALE: 1:100

4 FRONT FRAMING ELEVATION
3 SCALE: 1:100 FRAME #1

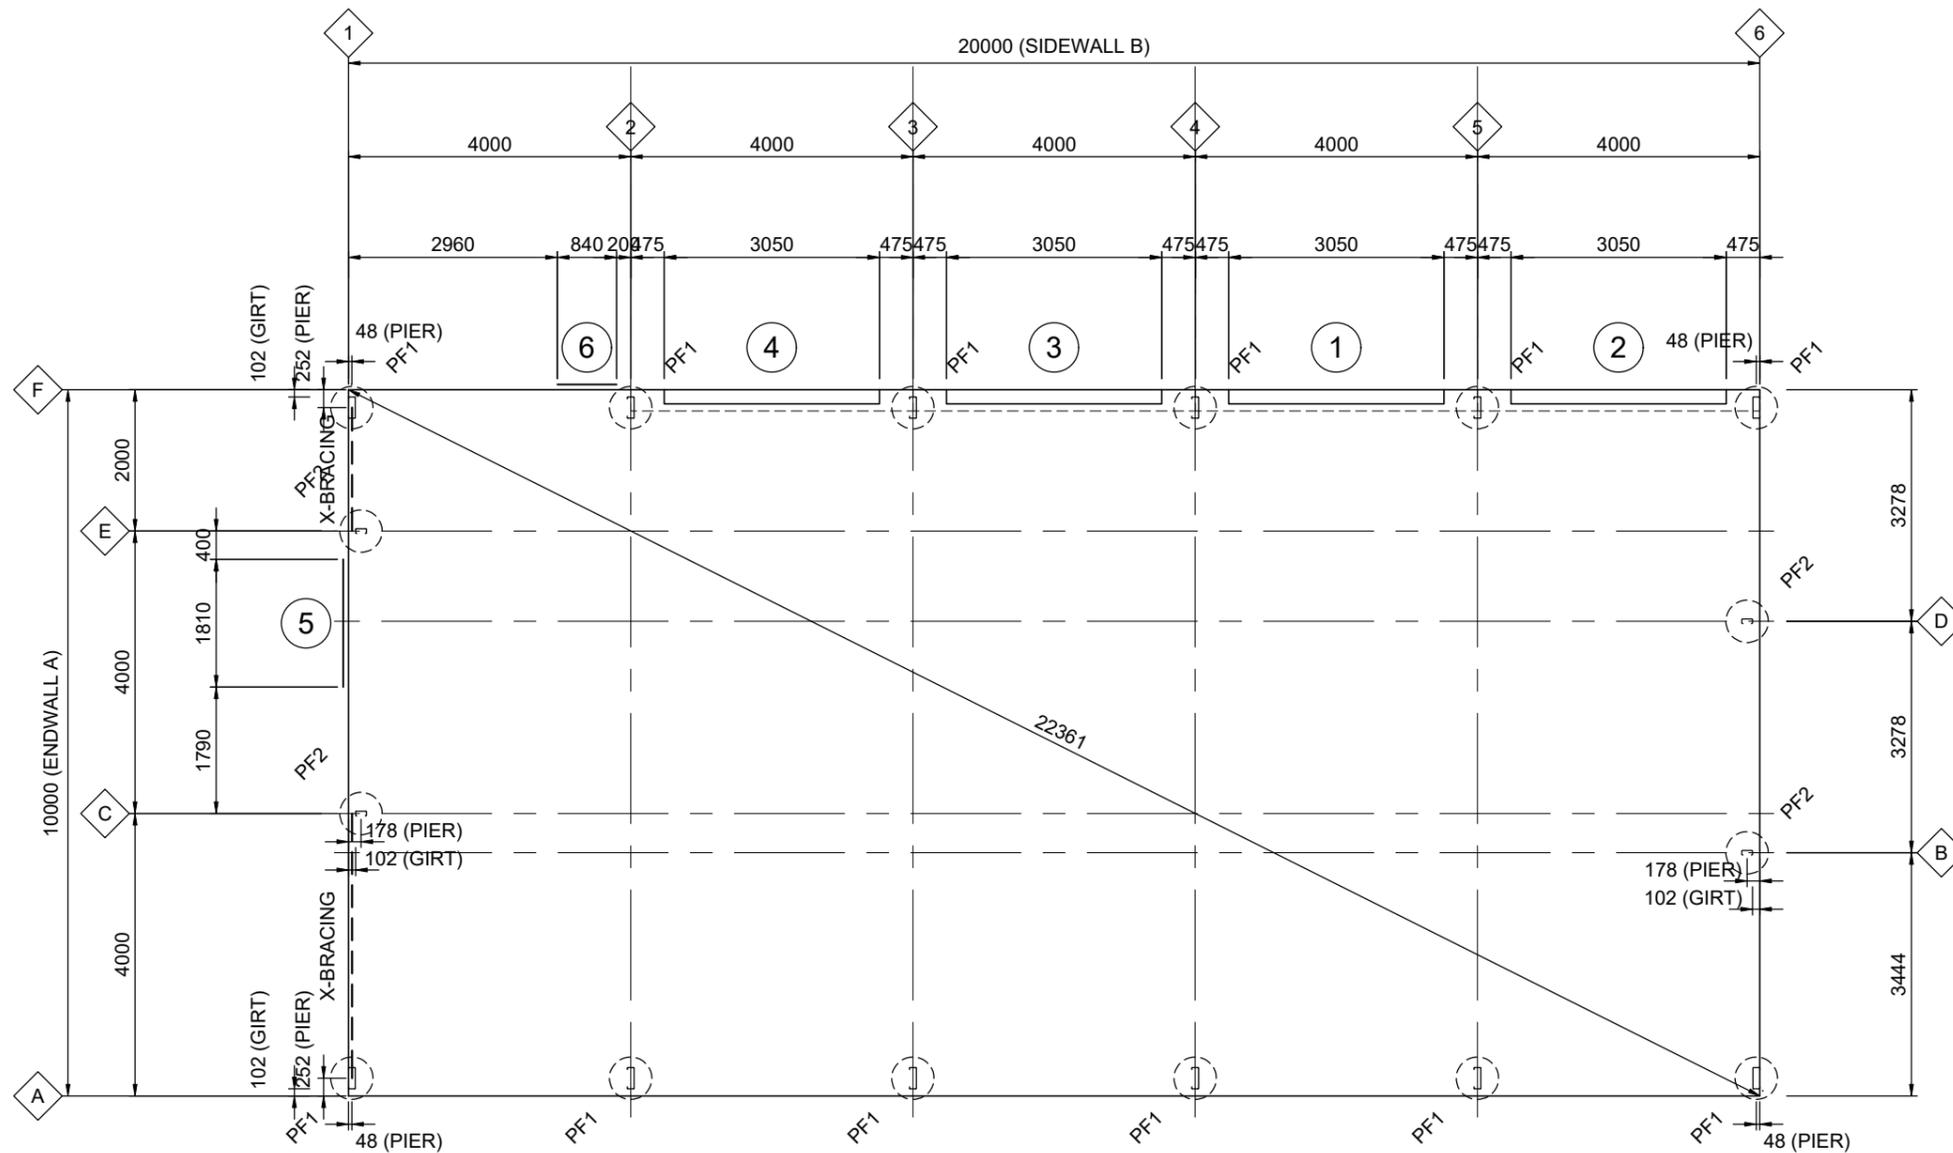
1 FOOTING/SLAB FLOOR PLAN

4 SCALE: 1:100 PF1 - 600Ø REINFORCED CONCRETE PIERS TO DETAIL
 PF2 - 600Ø REINFORCED CONCRETE PIERS TO DETAIL

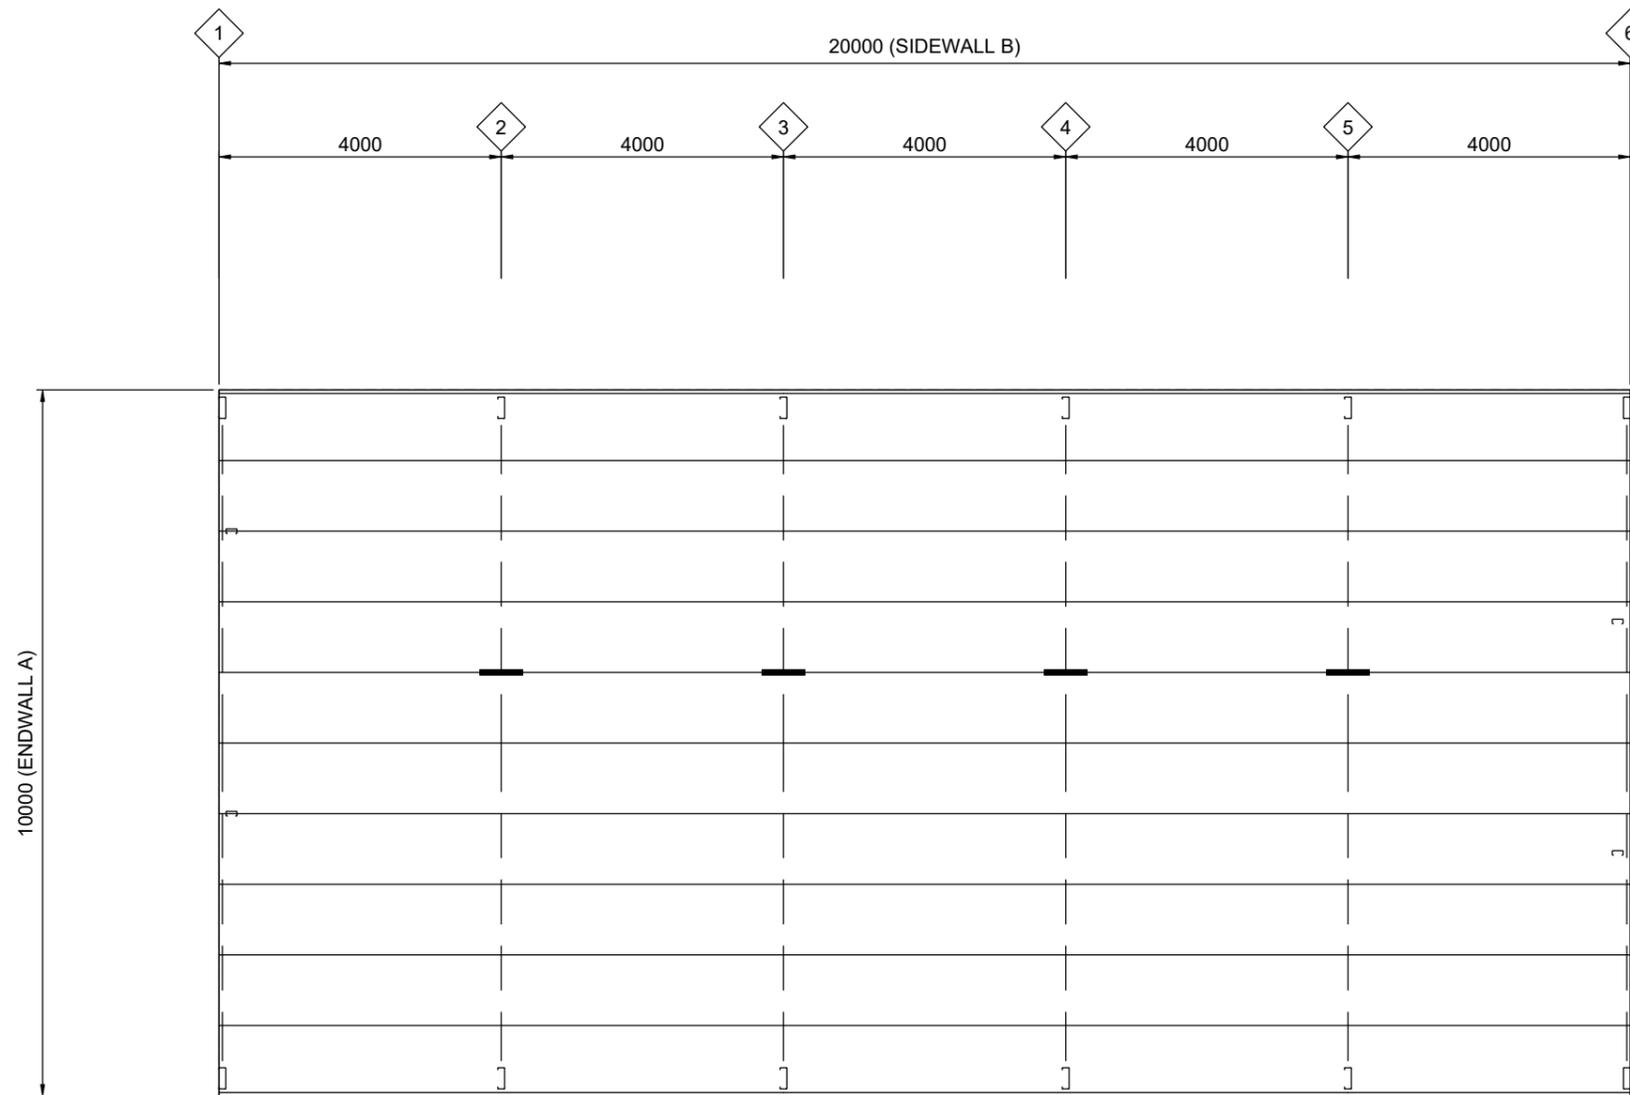
1 ROOF FRAMING PLAN
5 SCALE: 1:100

ROOF SHEETING IS USED AS DIAPHRAGM TO BRACE THE BUILDING AND IS NOT TO BE CUT UNDER ANY CIRCUMSTANCES

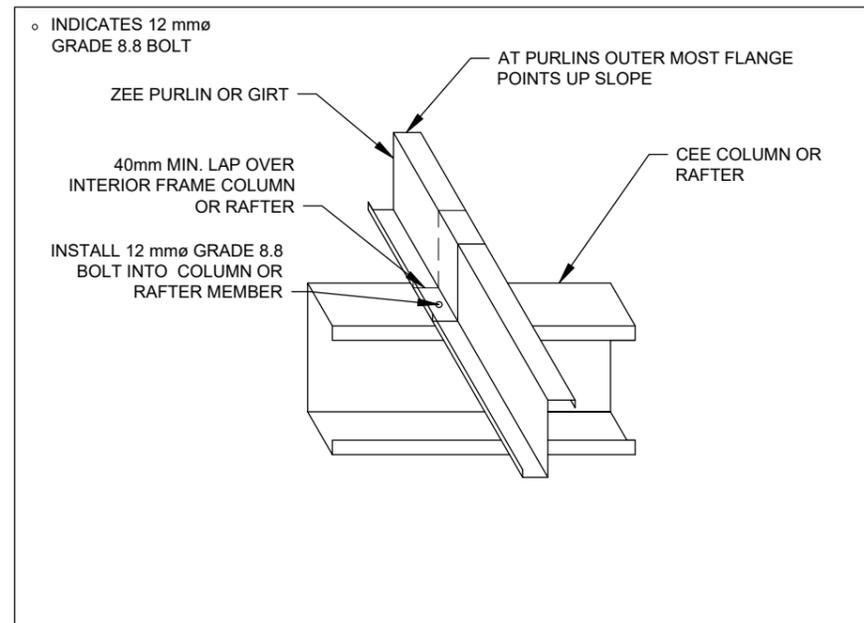
D ZEE PURLIN/GIRT CONNECTION

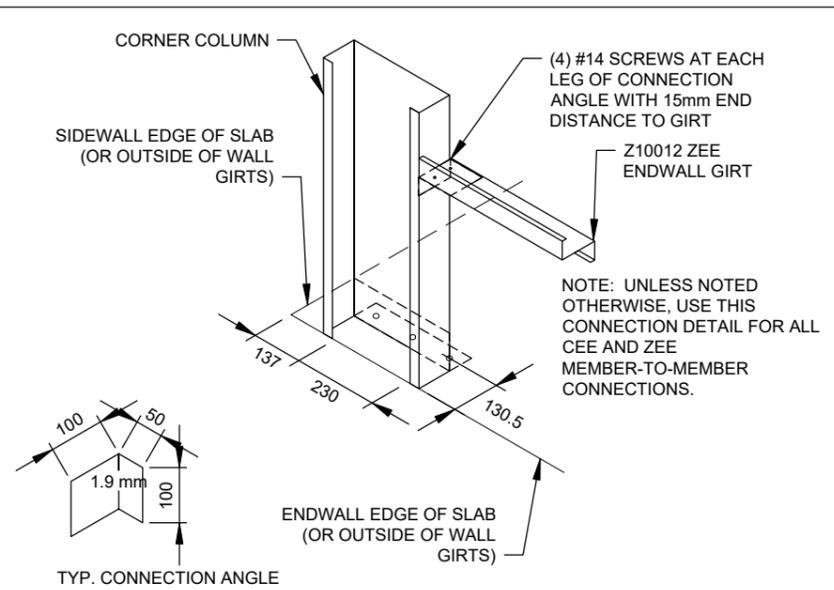
E GIRTS IN-LINE CORNER COLUMN CONNECTIONS

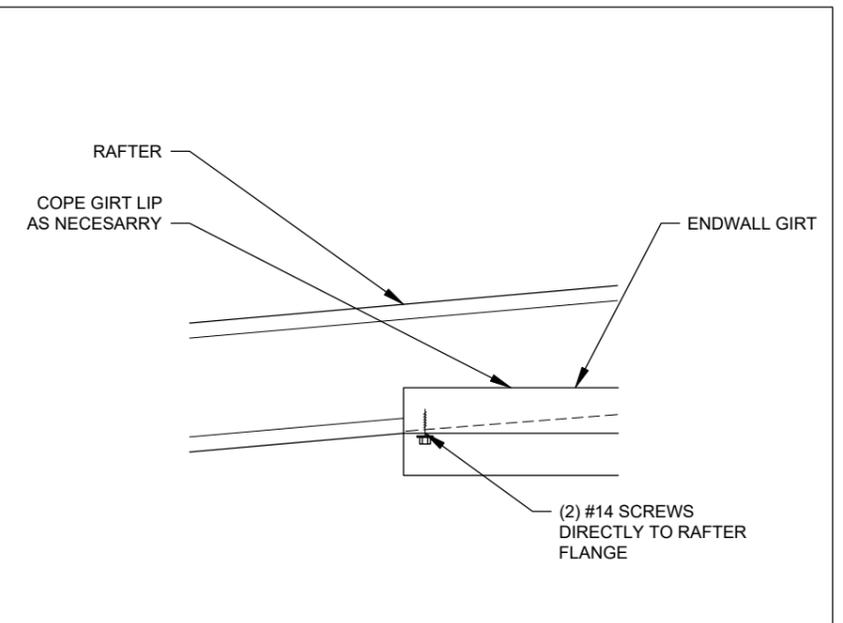
E2 END GIRT TO RAFTER

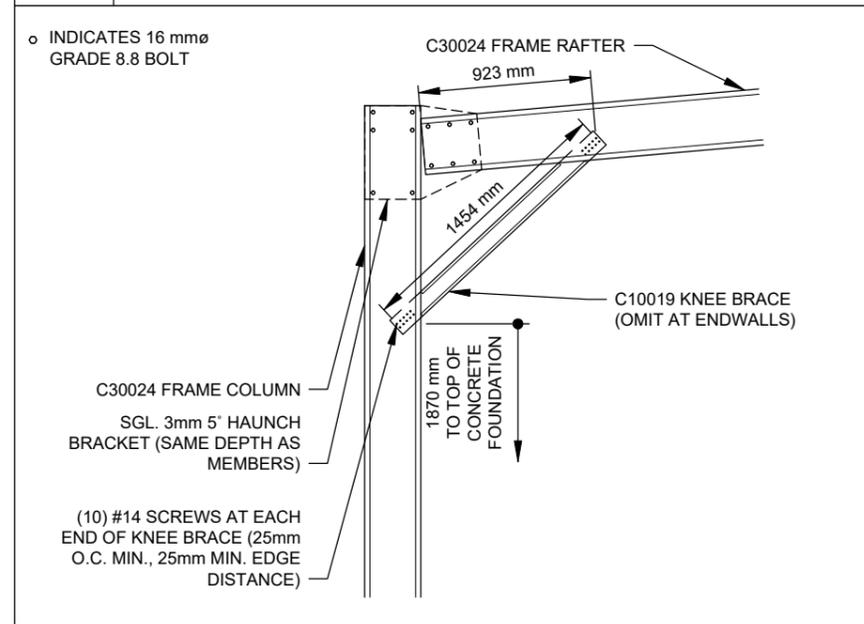
A HAUNCH CONNECTION

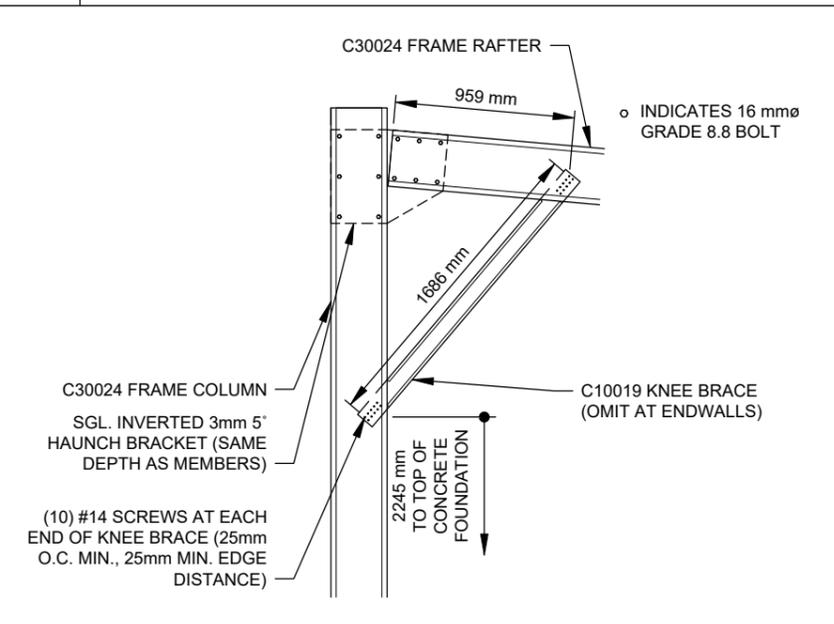
B HIGH EAVE HAUNCH CONNECTION

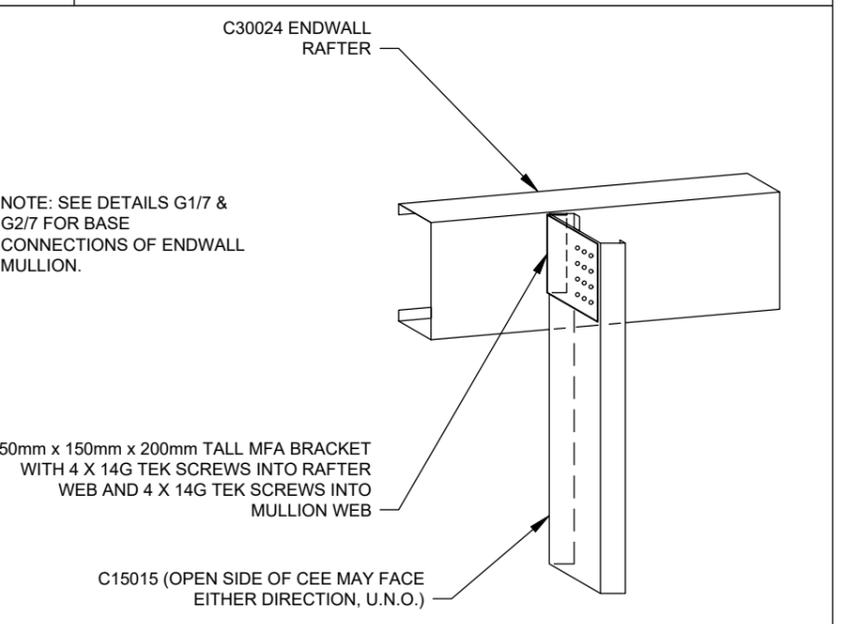
C ENDWALL MULLION TO RAFTER

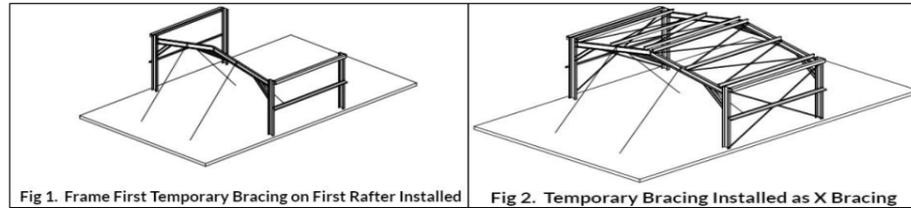
The location of Temporary bracing will depend on the installation method used. Installation should be completed in accordance with the Construction Package, Engineering Plans, and Instruction Manuals. If the Frame First Method (most common) is used, then the use of tension only bracing and creating temporarily braced bays as per Fig 1 and Fig 2. can be used. As a basic guide, a minimum of every 4th bay should have temporary bracing installed as per Fig 2.

If the Tilt Up Method is used (where walls are constructed on the ground and then tilted into place), then the tops of columns are braced with a tension and compression brace in the same direction Fig 3. Then rafters and purlins can be installed with temporary bracing holding rafters in place (similar to Fig 1) until final bracing of diaphragm sheeting is installed.

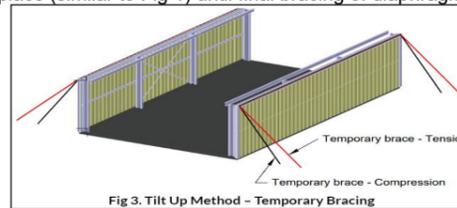
Typically, braces should be positioned diagonally across the structure from the top to the bottom, intersecting near the midpoint to provide stability, optimally at a 45-degree angle but no less than a 20-degree angle. The connection strength of temporary bracing is a critical consideration and these connections must be capable of resisting the potentially substantial temporary bracing loads – whether this connection point be to the building, the foundations or to the ground. Dependent upon building size this may include heavy angles and post installed concrete anchors. The temporary bracing methods used must be capable of fully stabilising the structure during the construction process.

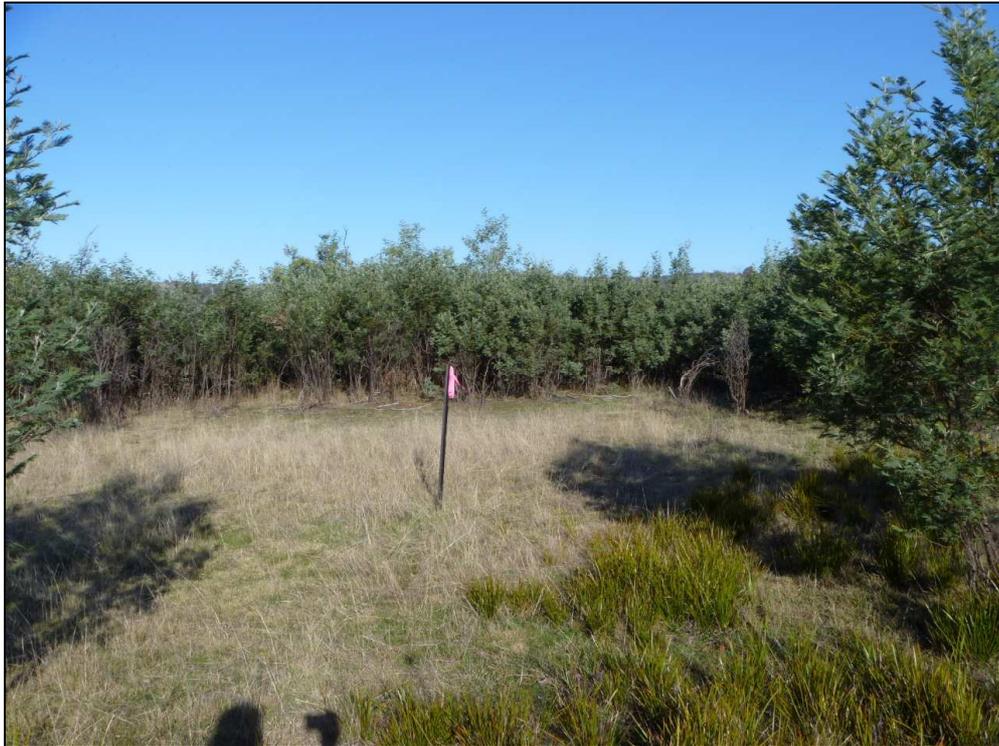
Figure 3 – *Acacia dealbata* woodland indicating dense stands of silver wattle.

Silver wattle (*Acacia dealbata*) is the dominant species throughout the community and occurs in very dense stands in some areas (Figure 3). Other scattered shrubs in this community include black sheoak (*Allocasuarina littoralis*) and prickly box (*Bursaria spinosa*) and there are emergent eucalypts also present in small numbers.

The community contains a number of small areas where native grasses are dominant with the shrub layer virtually absent (Figure3). These small patches are dominated by kangaroo grass (*Themeda triandra*), speargrass (*Austrostipa* sp.) and wallabygrass (*Austrodanthonia* sp.) and are consistent with the grassland community 'lowland *Themeda triandra* grassland complex - GTL'. This community is classified as a sub-type of the critically endangered vegetation community 'Lowland Native Grassland' under the 'Environmental Protection and Biodiversity Conservation Act 1999'. However the small size (<1 ha) of the remnants and their condition (low species diversity) means they do not meet condition thresholds to receive full protection or qualify as a matter of national environmental significance under the EPBC Act.

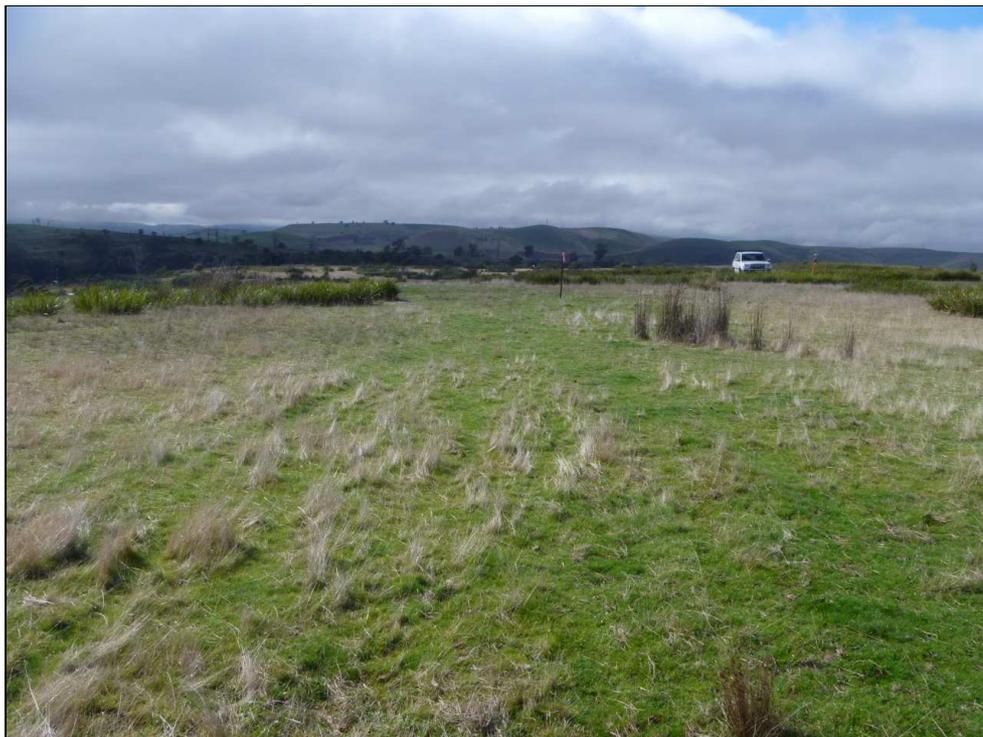
Figure 4 – Proposed location of Site 1

The residential house site is to be located towards the eastern side of the site close to the lake on a small rise (Figure 4 & 5).

The proposed location for this site is amongst cleared agricultural land with scattered native sedges, grasses and groundcover plants nearby to site (Figure 4). An unidentified skink species was sighted in close proximity to this site which may be a listed species, however no other values will be impacted by development in this location.

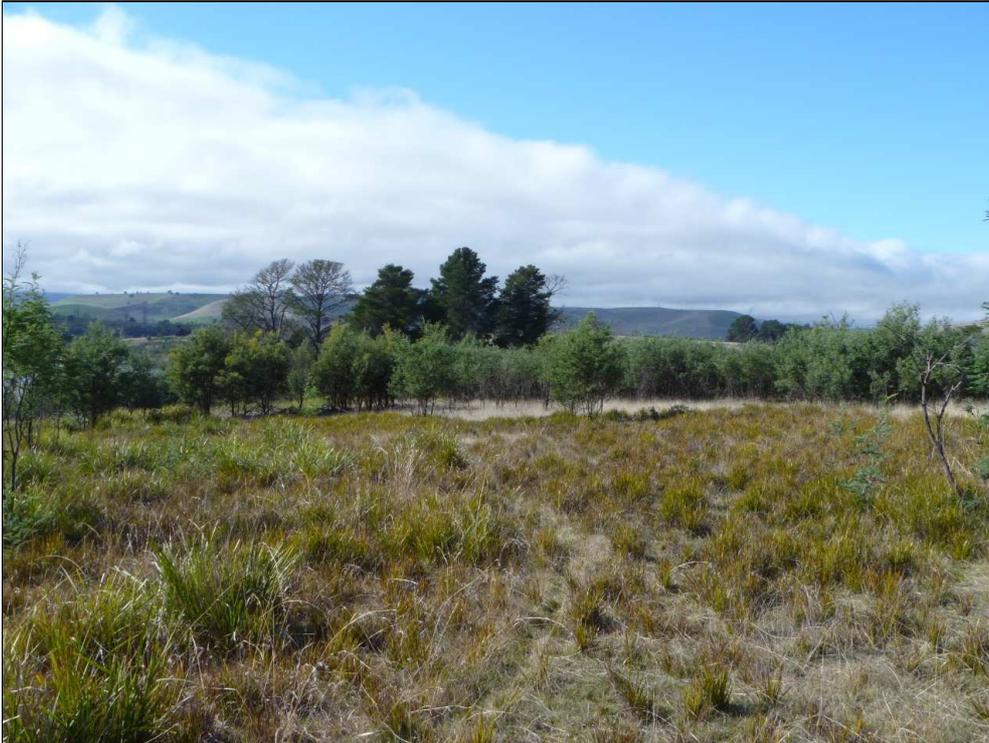
Figure 6 – Site 4 in open area amongst NBA.

Site 4 is proposed for the top of the small ridge adjacent to the lake edge amongst Bursaria-Acacia woodland with the access road through similar vegetation (Figure 5). The location contains an open area devoid of wattles with a groundcover of sagg, sword sedge and native grasses with no significant flora species or fauna habitat (Figure 6). The establishment of a structure on this site will have minimal environmental impacts.

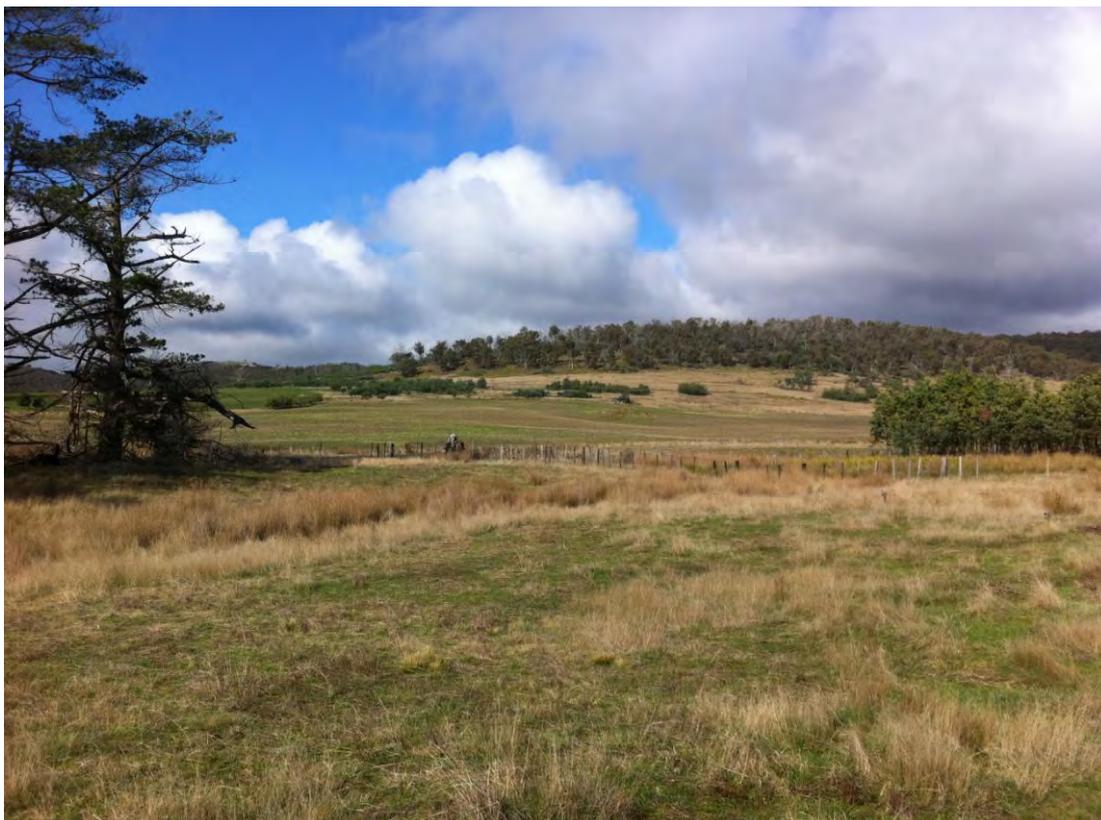
Figure 2 – Typical topography photo looking east across the northern end of the property.

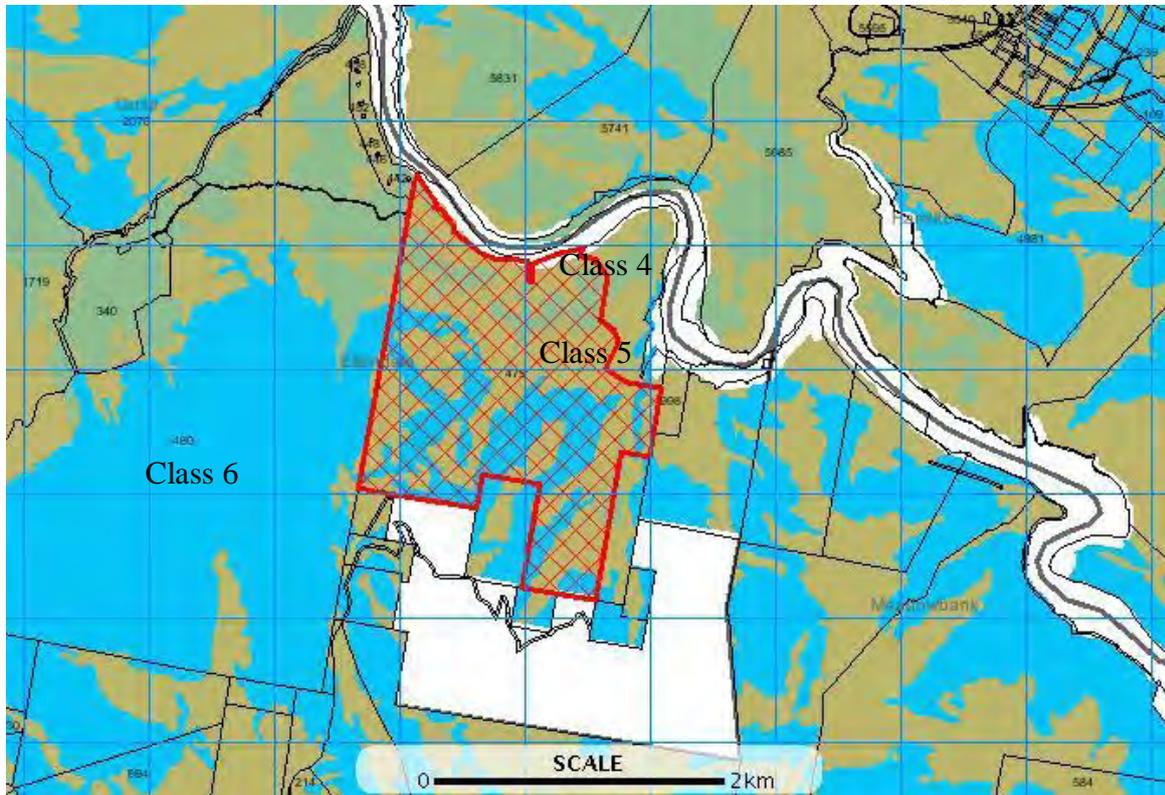
Figure 4: Existing 1:100 000 Land capability mapping showing areas of Class 5 and 6 land with small areas of Class 4 land on the lower slopes of the property (deemed inaccurate by field survey).

The 1:100 000 Land Capability map is produced by modeling a combination of factors to determine land capability. The resolution of that mapping is very low, and has in many cases not been corrected by field survey testing. From our own landscape and soil evaluation the majority of land capability mapping is incorrect, in particular the classification of much of the forested and lakeside land with a majority of rocky outcrops being classified as Class 5. From our field survey data we have produced a corrected map of land capability.

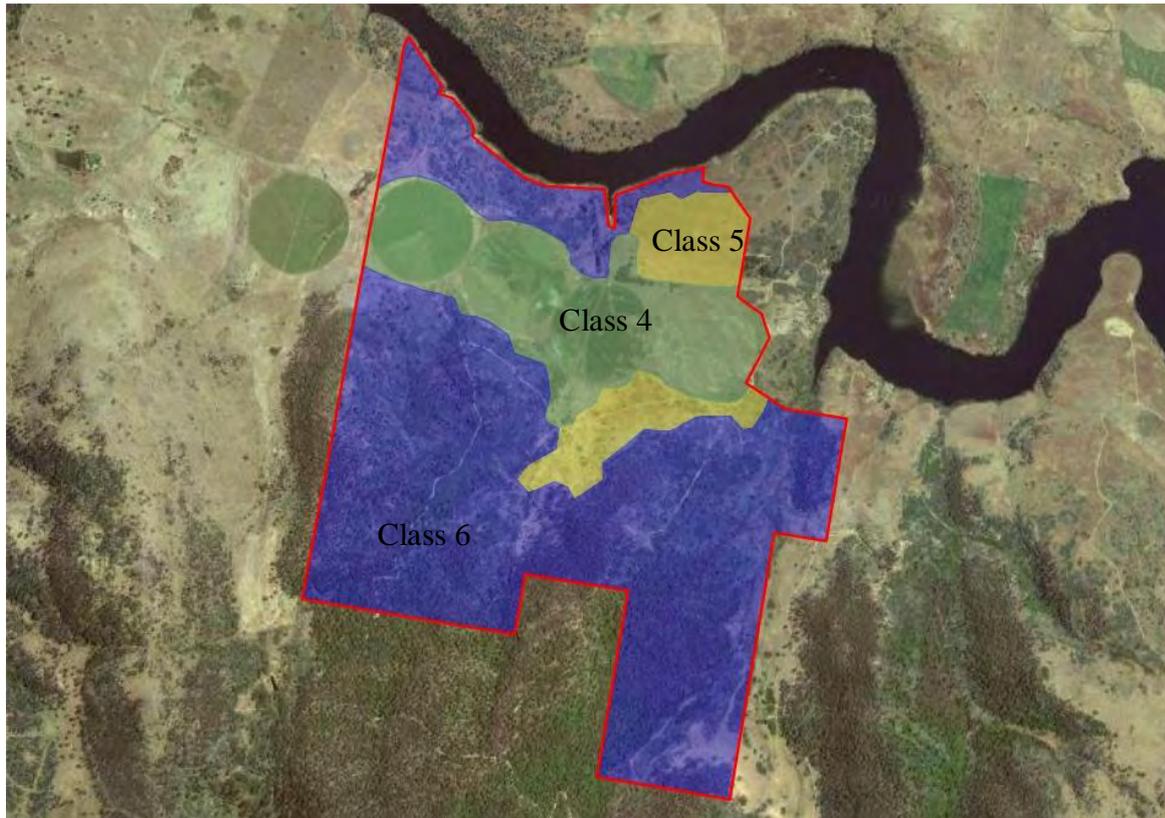
Figure 5: Revised land capability mapping from detailed site survey.

The results from the field survey show the agricultural capability of the land is generally low and is limited by shallow infertile well drained soils, low rainfall, and high soil erosion potential. The low inherent land quality combined with local climatic conditions imposes significant limitations to agricultural production. The areas of land best suited to agriculture, and classified as Class 4 land, are found on lower cleared slopes on the northern end of the property.

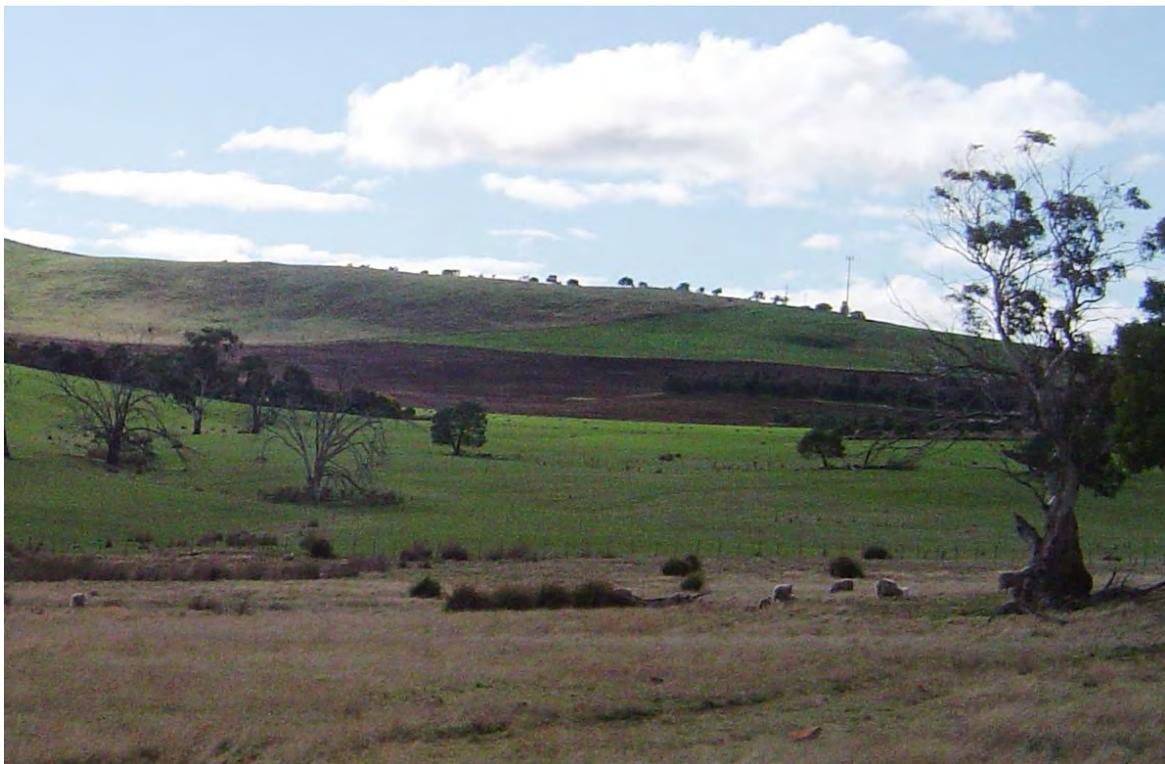
Figure 6 – View looking to class 4 land in the distance (file photo).

Generally it is recommended that cropping on class four soils be limited to one to two years out of ten in a rotation with pasture or green manures to avoid soil structural decline. Class 4 land on Tertiary and Quaternary Alluvium in South East Tasmania is commonly utilised for cropping where irrigation infrastructure is available (eg South East Irrigation area around Richmond) as climate and soil moisture can severely limit dry land cropping options. The primary limitations identified on the site were areas of shallow soil, low rainfall and potential for soil erosion. The class 4 land on the site is all in the northern slopes of the property with some irrigation infrastructure in place and some development potential.

The class 4 land surveyed would be suitable for grazing and occasional intermittent grain cropping.

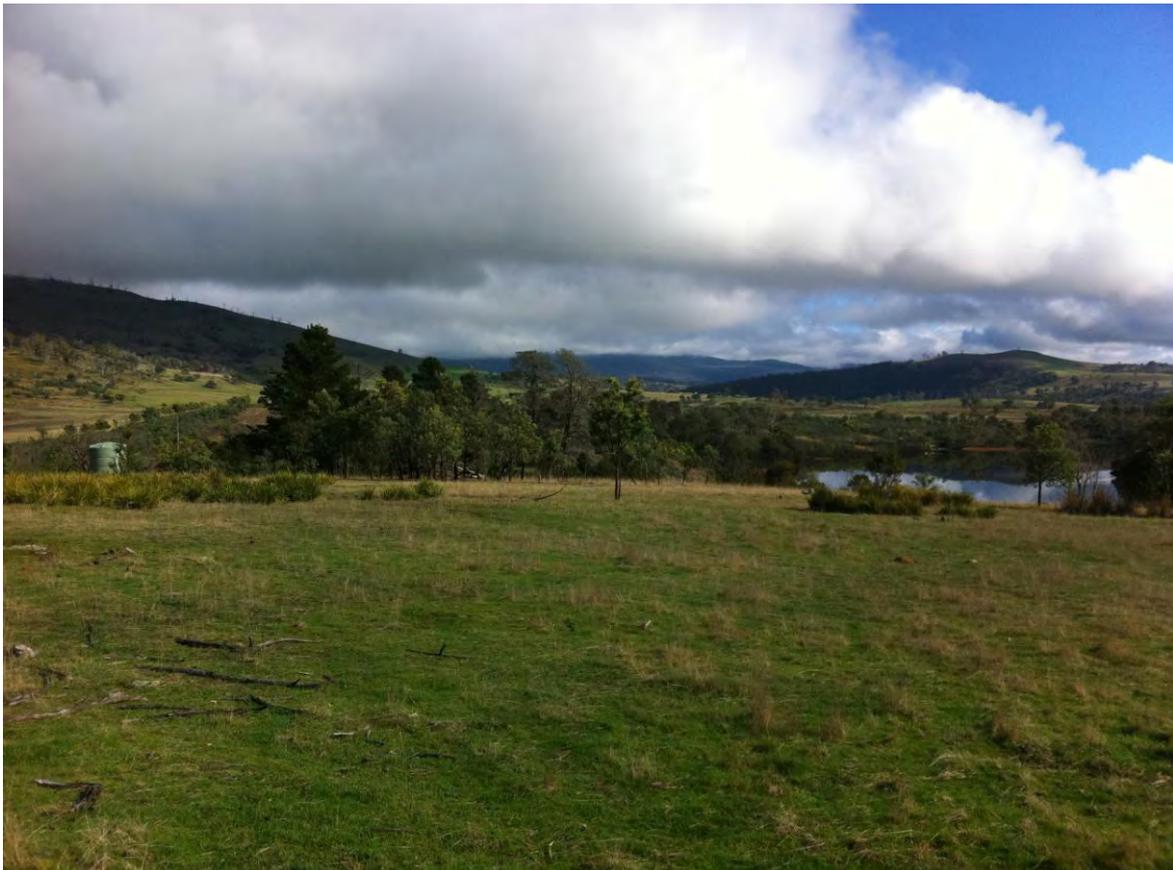
Figure 7 – View looking across class 5 land.

The areas of class 5 land surveyed would be suitable for low density grazing, provided adequate management of soil erosion risks and soil drainage. According to the report of Musk and DeRose (2000) small inclusions of class 4 and 6 land are common within class 5 land, with the class 4 land usually found on concave slopes and colluvial deposits while the class 6 land is more common along ridge crests and slopes over 28%. Field survey of the site agrees with this topographic interpretation of the class distribution.

Small areas of Class 5 land are present on the steeper slopes with shallow soils that are entirely unsuitable for any tillage or cropping. The main limitations to agriculture on the class 5 land being erosion risk from moderate slopes (Musk and DeRose give 18-28%), stone content and the climatic limitations of a range of possible agricultural enterprises.
