Application Number:	DA 2026/20
Application Type:	Discretionary Development Application
Property Location:	473 Rockmount Road, Ellendale
Proposal:	Outbuilding
Advertising Commencement Date:	18 March 2026
Representation Period Closing Date:	01 April 2026
Responsible Officer:	Louisa Brown, Senior Planning Officer

**PROPOSED COLORBOND SHED
 (20m x 10m)**

**473 ROCKMOUNT RD,
 ELLENDALE, TAS - 7140**

INTRODUCTION

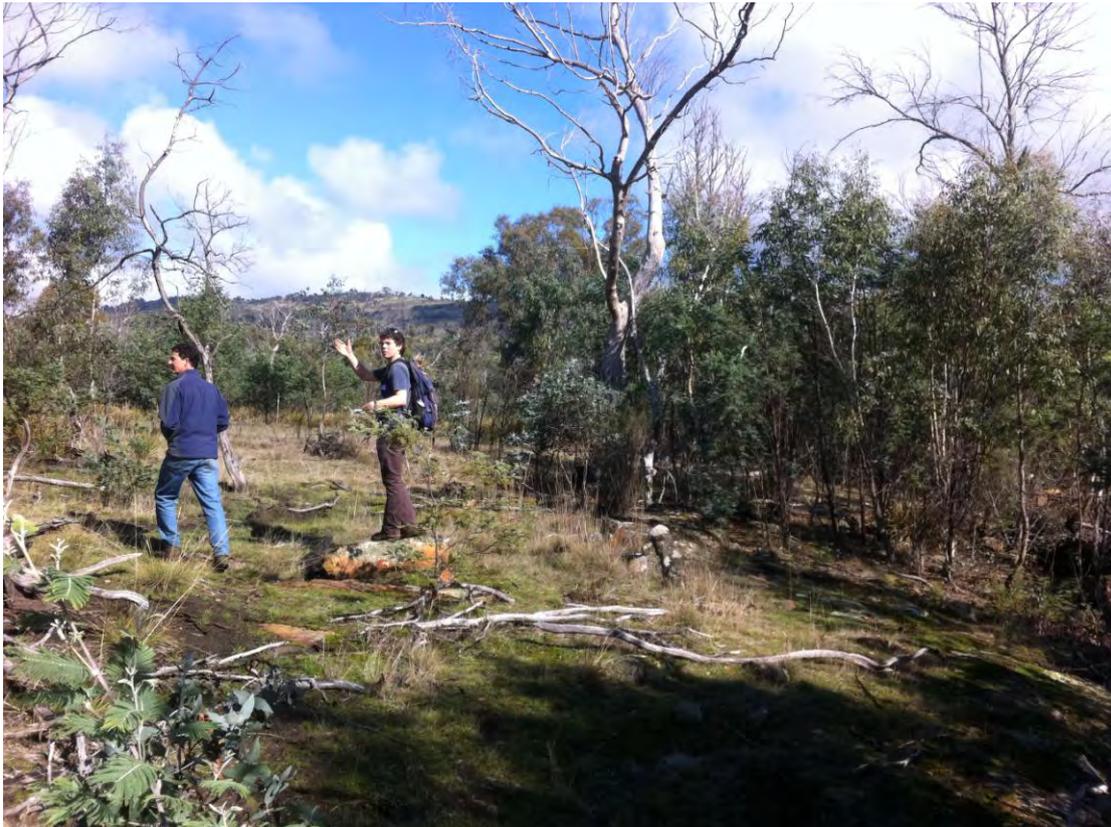
Figure 8 – View of Class 6 land with very shallow infertile soils with sparse native vegetation, some forested areas and some protruding rocky outcrops.

Class 6 land is described as “*Land marginally suitable for grazing because of severe limitations. This land has low productivity, high risk of erosion, low natural fertility or other limitations that severely restrict agricultural use*”. The areas of class 6 land on Triassic sandstone is characterised by shallow soils with rock outcropping, and high erosion potential. The area of class 6 land includes the forested areas with some rocky outcrops and the very rocky land immediately adjacent the lake.

It is generally recommended that these areas be excluded from all stock, and that appropriate rehabilitation and revegetation plans are developed to prevent further land degradation.

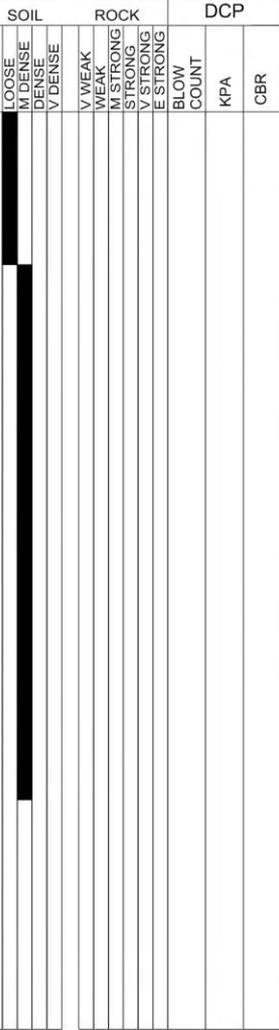
A1	10YR 5/1	M	Grey (10YR 5/1) SAND (SP), loam fabric, weak polyhedral structure, common fine roots, moist loose consistency, irregular boundary to
