Demolition, Alterations & Additions, Change of Use Barn to Visitor Accommodation

DA 2020 / 00079

Planning Permit Application for alterations and additions

ALTERATION & ADDITIONS - 'Strathborough' - 2120 Hollow Tree Road, Hollow Tree, Tasmania

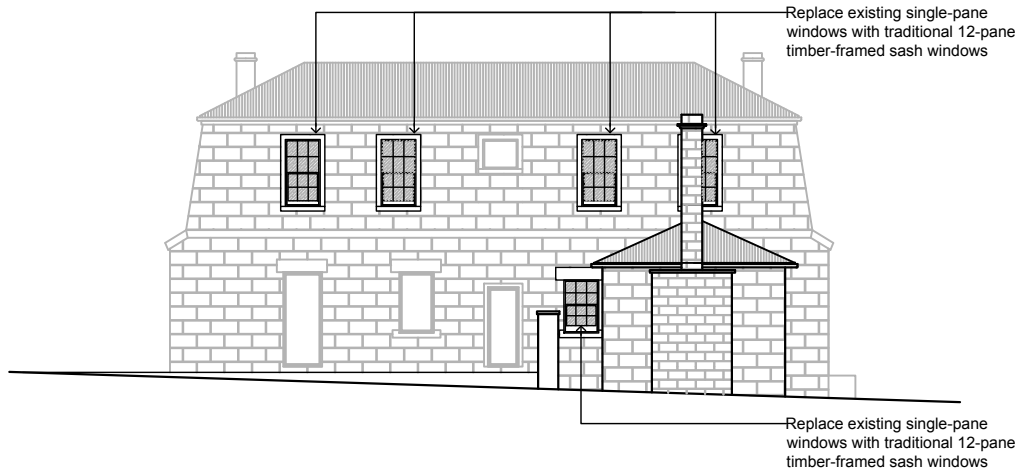
01 HOUSE REAR ELEVATION - WINDOWS TO BE UPGRADED
1:200

The proposed works to the Homestead include the replacement of the single-pane sash windows with traditional 12-pane sash windows; the construction of the second dormer window which was demolished by previous owners, re-built to match the existing surviving dormer, and the reinstatement of the existing stair window. Refer drawings for details.

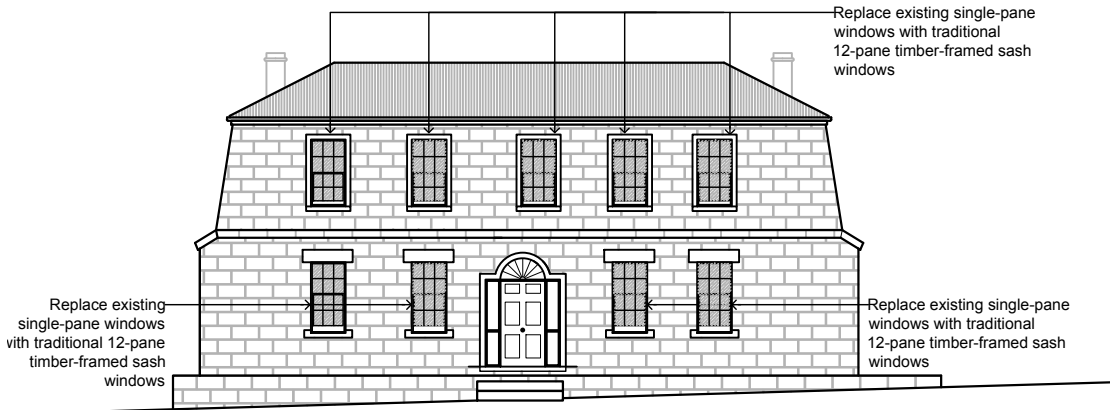
02 HOUSE FRONT ELEVATION - WINDOWS TO BE UPGRADED
1:200

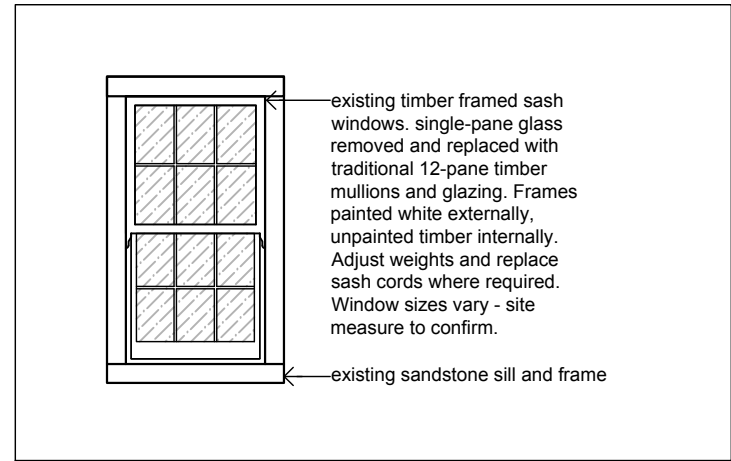
08 12-PANE SASH WINDOW TYP.
1:50

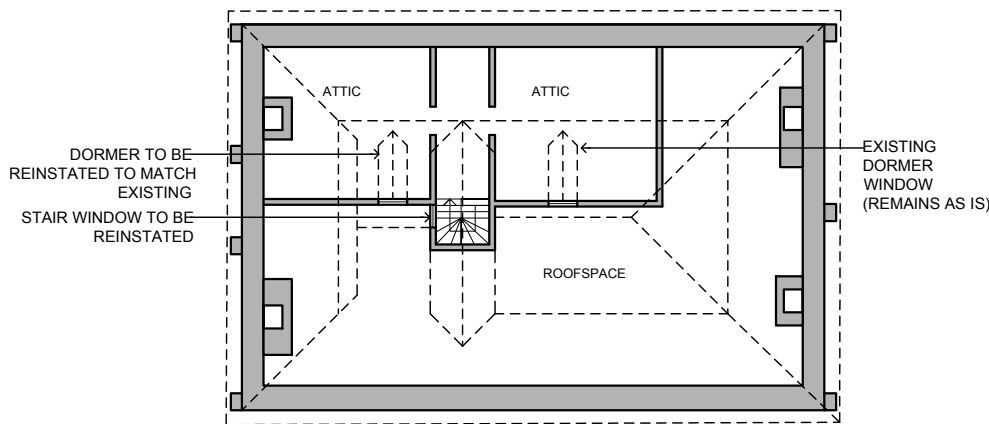
03 ATTIC LEVEL PLAN - REINSTATE DORMER AND STAIR WINDOWS
1:200

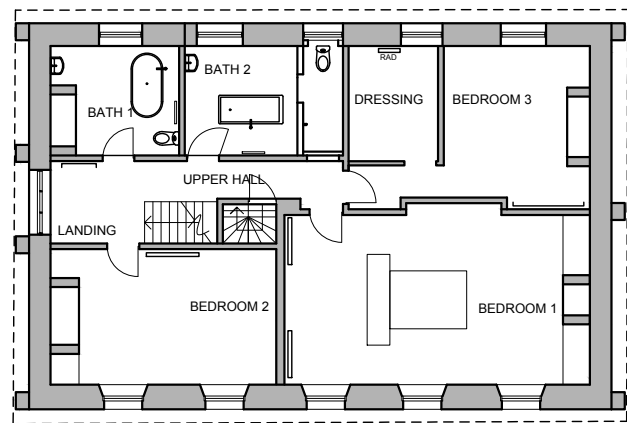
05 LEVEL 1 PLAN - EXISTING (NO NEW WORKS EXCEPT FOR WINDOW REINSTATEMENTS)
1:200

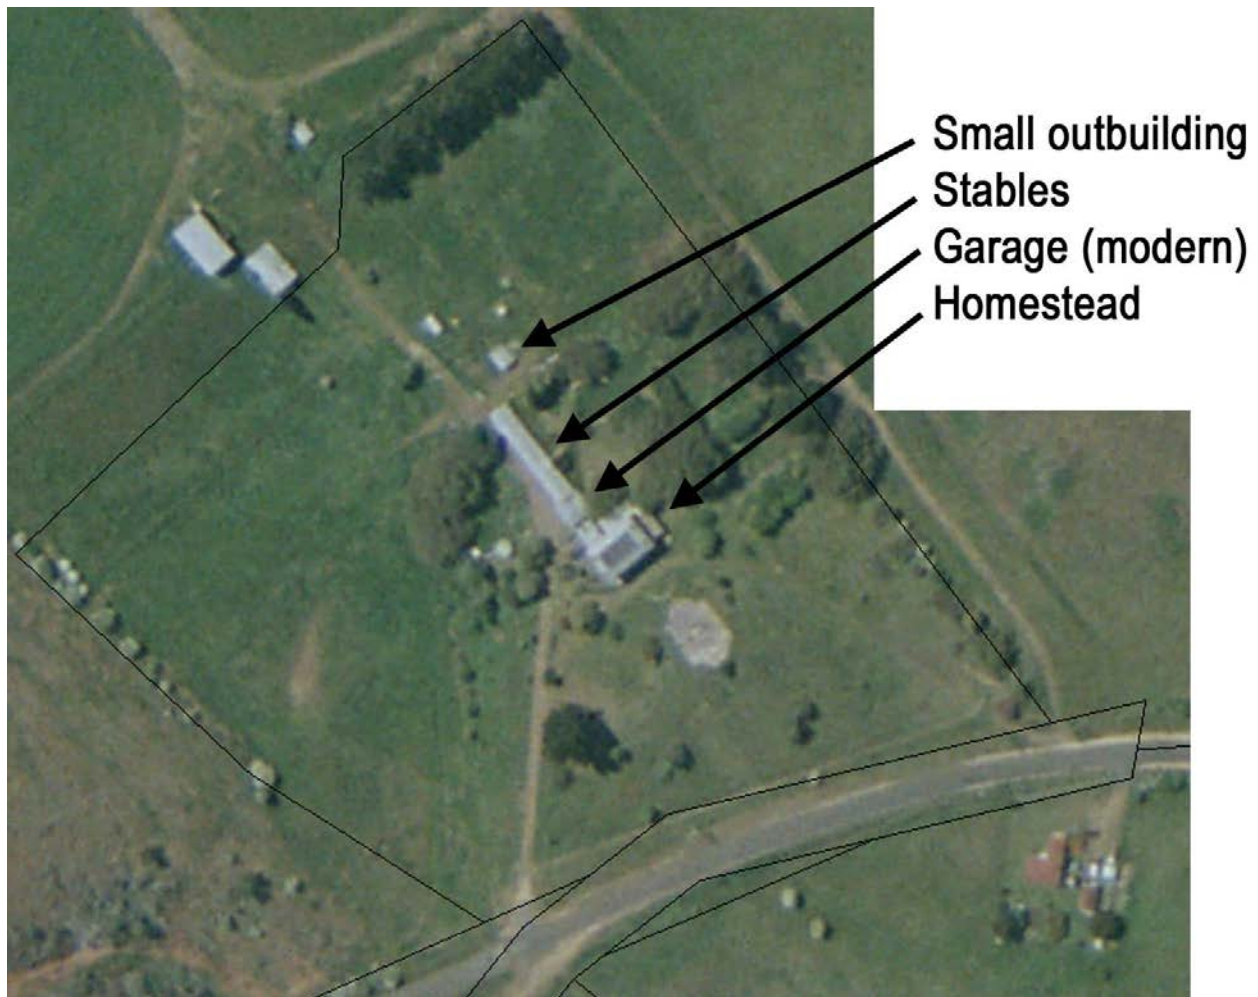
Figure 1.3 – A recent aerial photograph of the subject site with major site features (www.thelist.tas.gov.au)

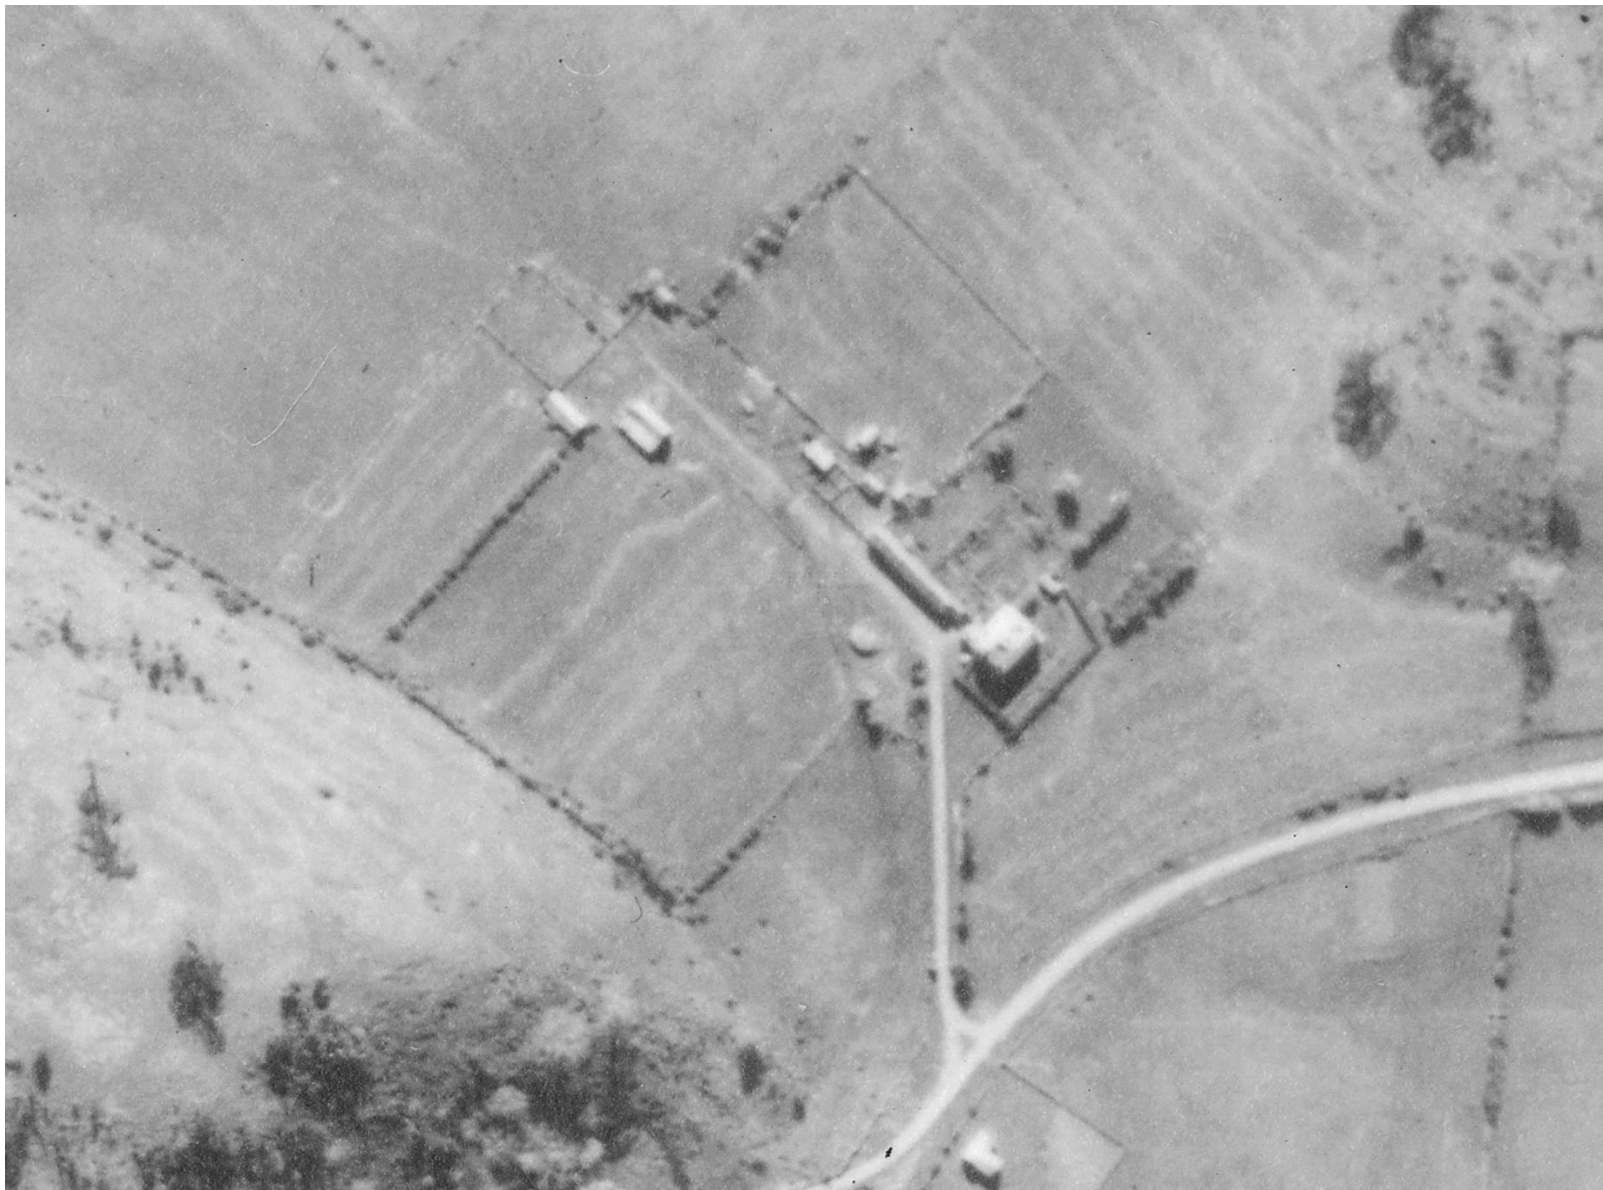
Figure 3.2 – Excerpt from a 1946 aerial image of Strathborough homestead and environs. DPIPWE 0036-501.

No early images of Strathborough were found in the course of this research. Figure 3.2 is the earliest depiction that could be located (1946):

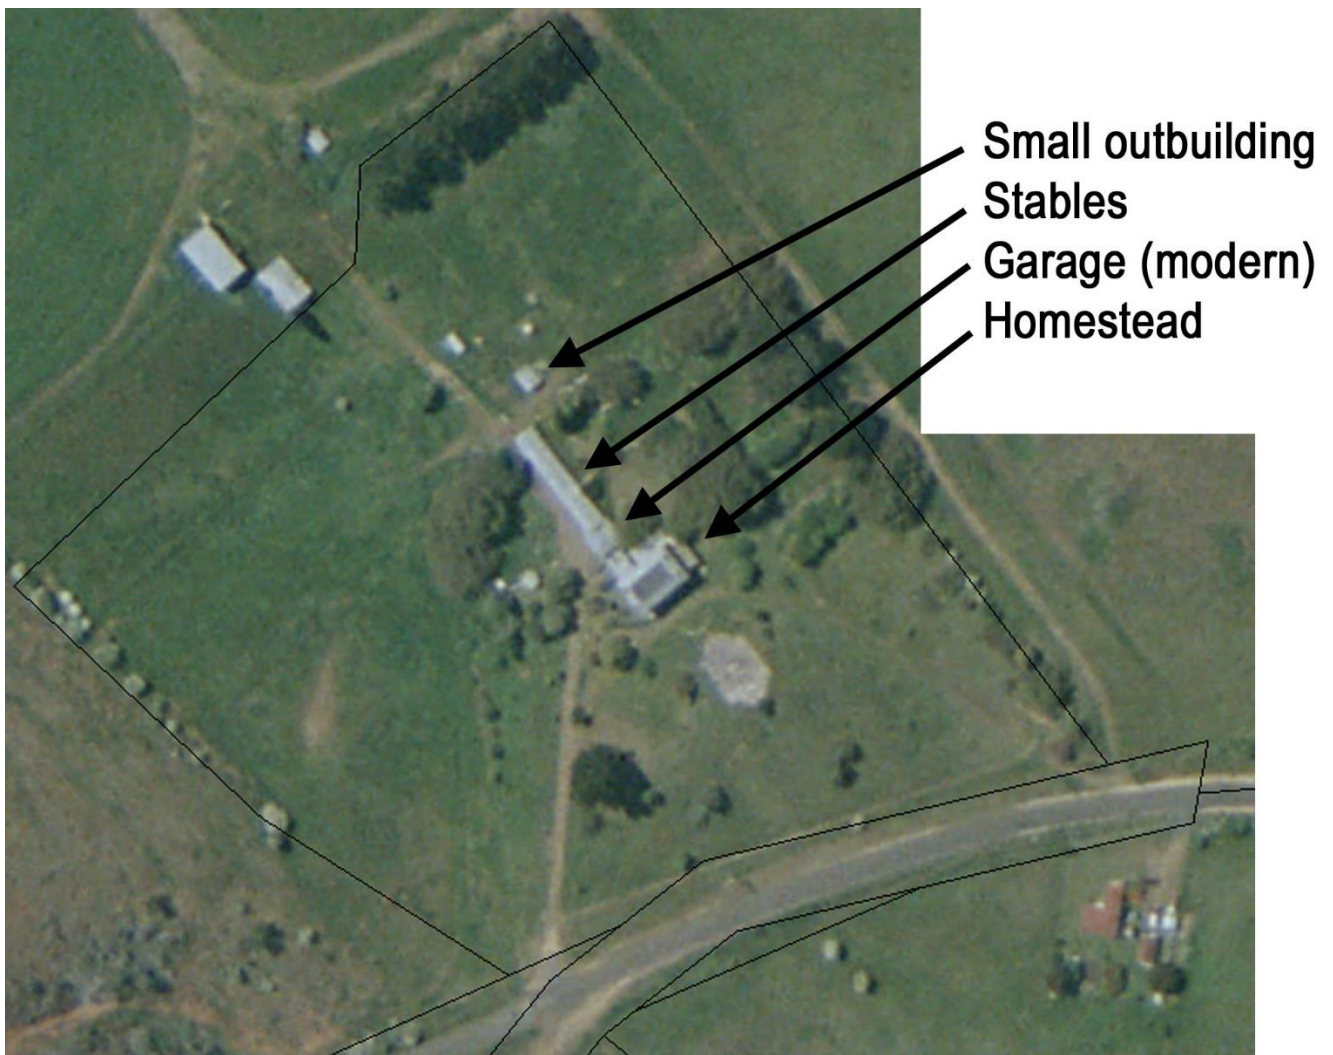
Figure 5.1 – Broad layout of the site and title boundaries (adapted from www.thelist.tas.gov.au)

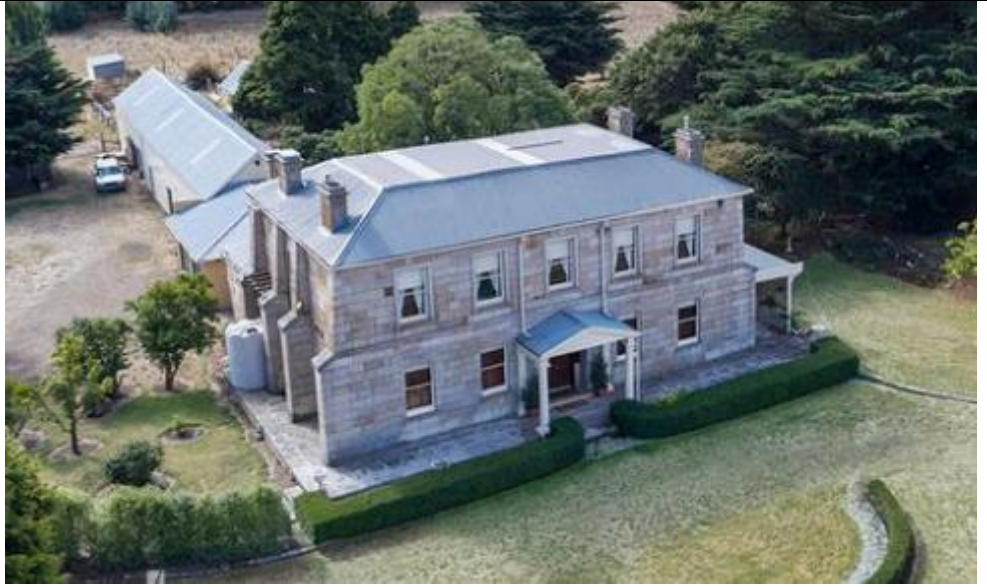
Element	Description, history and integrity	Image
Generally	<p>The Strathborough homestead is a substantial Georgian (c1827-32) homestead with a shallow pitched hipped roof clad in corrugated iron (over shingles). The roof form has an internal valley into which two dormer windows once opened (now covered with a modern cap). Four symmetrically placed sandstone chimneys flank each side of the roof form. The building has sandstone walls which are reasonably well executed in appearance, however have some structural deficiencies (as further discussed below). The façade has a finer quality of cut and finish than the sides and rear which is typical of such buildings. The upper level windows have unusual and distinct stone surrounds which are absent from the ground floor and gives a false impression of the upper level being added later, which there is no evidence to suggest. The windows on the front and rear elevations are two-pane timber-framed sashes, which probably derive from a c1920s renovation and probably replaced typical twelve-pane sashes. A scullery wing at the rear is likely to be contemporary with the build of the main body of the building. The building has substantial sandstone buttresses on each side which are an early structural intervention but blend almost seamlessly with the stonework of the walls. A sandstone plinth surrounds three sides of the building. The rear elevation has been obscured by a sunroom and the ground floor of which has modified apertures. A garden wall at the rear is probably a later addition from recycled stone.</p>

An aerial photograph of the Strathborough homestead, a two-story Georgian-style house. The building features a hipped roof clad in corrugated iron, with four sandstone chimneys visible. The walls are made of sandstone. The house is surrounded by a well-maintained lawn and mature trees. A small garden wall is visible in the foreground.

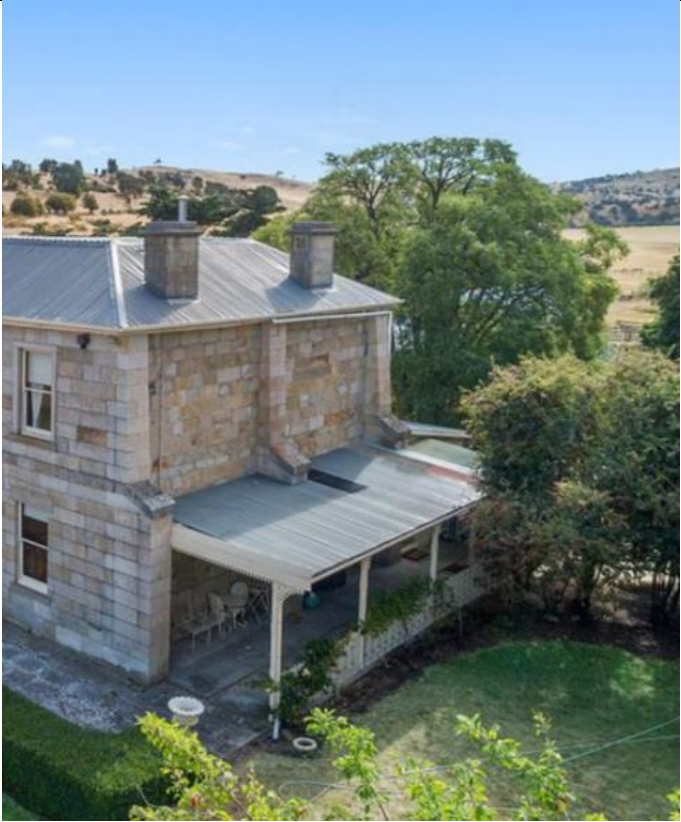
<p>Northern elevation</p>	<p>The northern elevation was originally a completely blank wall, with the two windows to the dining room on the rear ground floor crudely cut in at a later date. The buttresses were also added later which break the elevation. A much later veranda has been added over the original sandstone plinth. This elevation perhaps gives the most ‘fortress-like’ appearance of the building – intentionally ‘blind’ despite this elevation having good solar access. The sandstone of this wall is a slightly lower finish quality than the front and rear elevations, which is not uncommon in such buildings.</p>

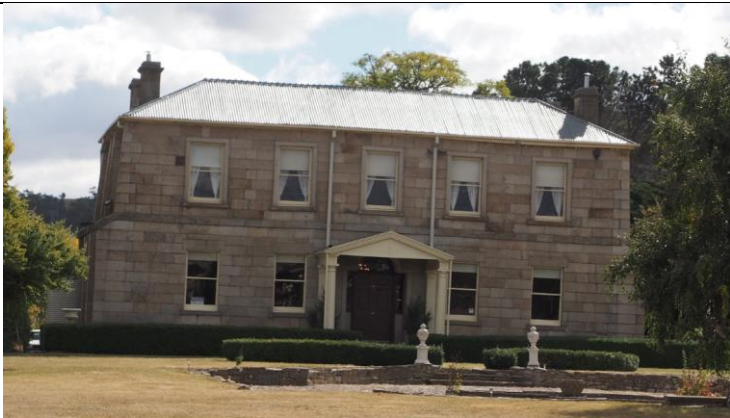
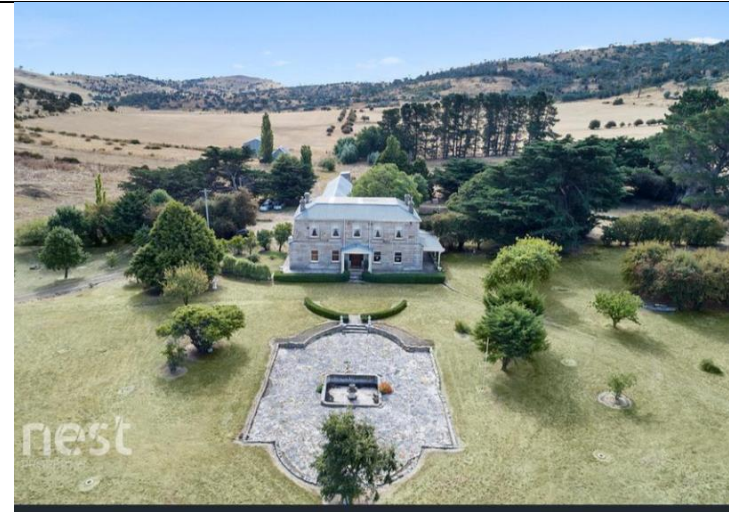
<p>Photo – Nest Property.</p>
<p>Eastern elevation (façade)</p>	<p>The very imposing façade of Strathborough works in unison with the wide and sweeping front lawns to give a very gran appearance of a country estate. The typically Georgian symmetrical façade is given a more robust appearance with the later addition of the buttresses and is flanked by the chimneys which surmount the shallow-pitched hipped roof with internal hips. The sandstone is of high quality appearance, despite further examination revealing that the stone is merely a thin ‘veneer’ with the blocks themselves unusually shallow.</p> <p>The front door has an arched fanlight and a pair of sidelights in typical</p>

Georgian fashion. The windows have been replaced, probably originally being twelve-paned sashes – the loss of that detailing giving this elevation a less imposing feel of a Georgian homestead. The portico over the front door is a later addition which detracts from the Georgian starkness and simplicity of this elevation. The stone terrace forms a transition from the grounds to the homestead.

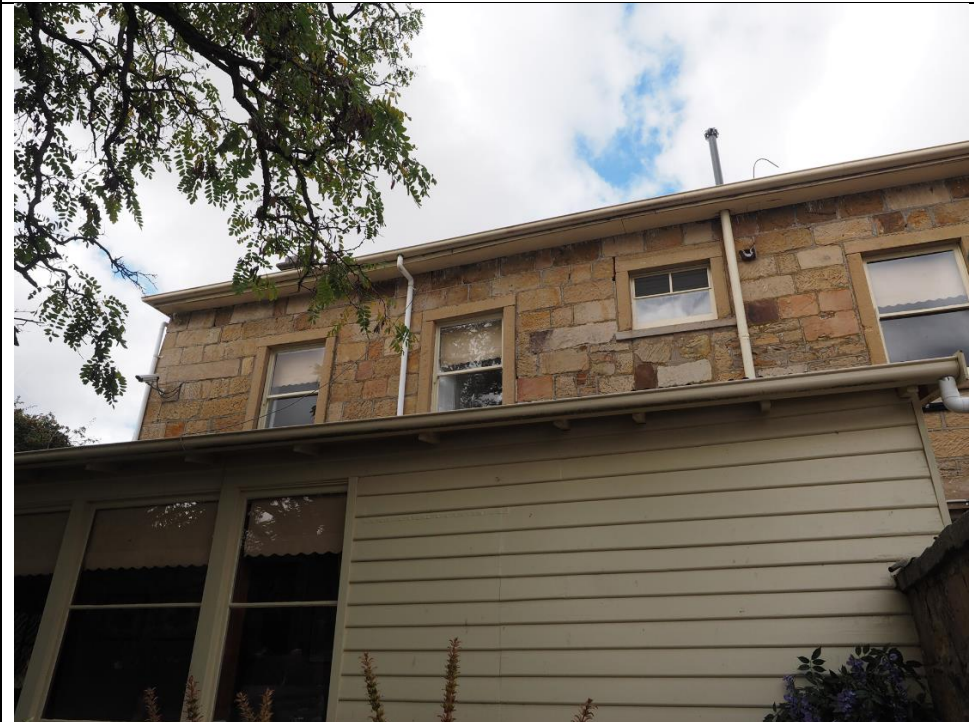
Western elevation

The western (rear) elevation of the building has a symmetry which has been broken by the scullery wing – which is probably original. The central upper window appears to have originally been a door, then reduced to a high window (probably when that internal area was converted to a shower then later to a toilet). This is an odd feature as it is unclear what such a door may have led to – there is no evidence of a rear balcony, central wing or steps and such a feature would be an unusual design element in such a building.

The ground floor elevation has been obscured by the sunroom and the fenestrative pattern changed by the conversion of the dining room window to a door and the filling of the other window to that room. A sandstone wall forms one side of the sunroom and continues westward into the garden. This is probably not original and may be recycled sandstone from garden walls or outbuildings and may be contemporary with the stables.

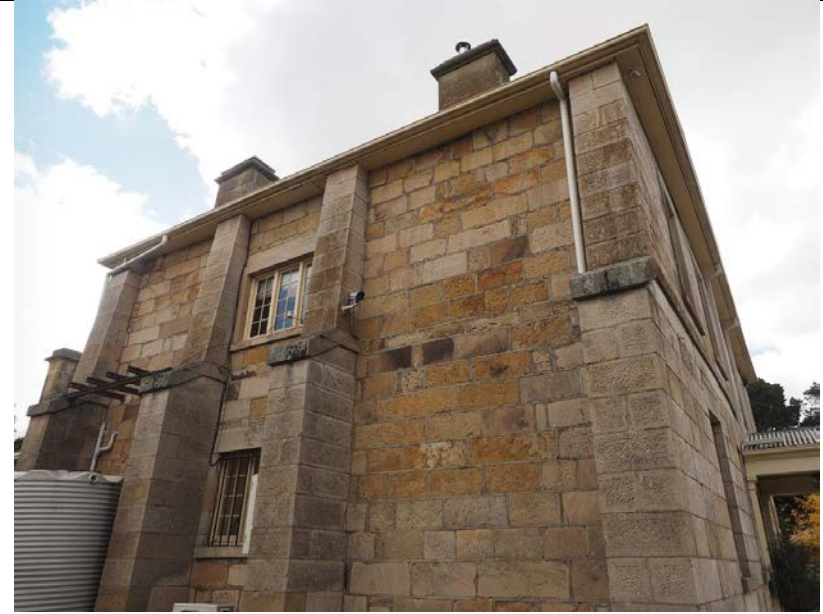
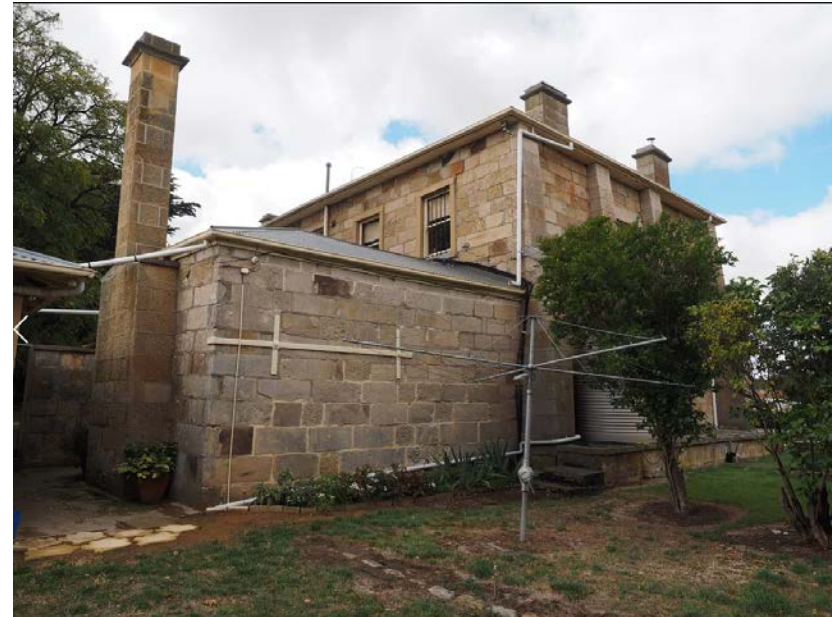
Southern
elevation

The southern elevation is similarly stark like the northern elevation, however does have two windows in the central bay which both appear original (the first floor certainly is). This elevation is similarly broken up by the later addition of buttresses.

At the rear of this elevation is the blank side wall of the scullery wing.

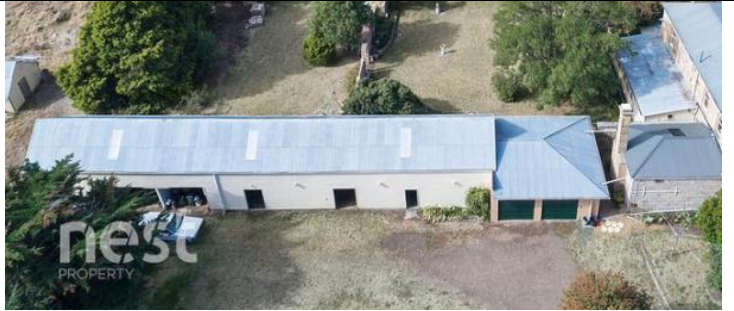
Element	Description, history and integrity	Image
Generally	<p>The stables comprise of five main bays with a range of opening sizes mostly accessed from the southern elevation. The building is later than the homestead and appears from the construction methods and fabric to date from around 1900. The building has concrete strip foundations and is mostly clad in weatherboard and has a simple steeply-pitched gable roof. Some sandstone has been used in its construction but this is certainly recycled and not in-situ in terms of its original location. There is a more recent garage addition on the eastern end and that entire end wall has been replaced contemporary with the garage.</p>

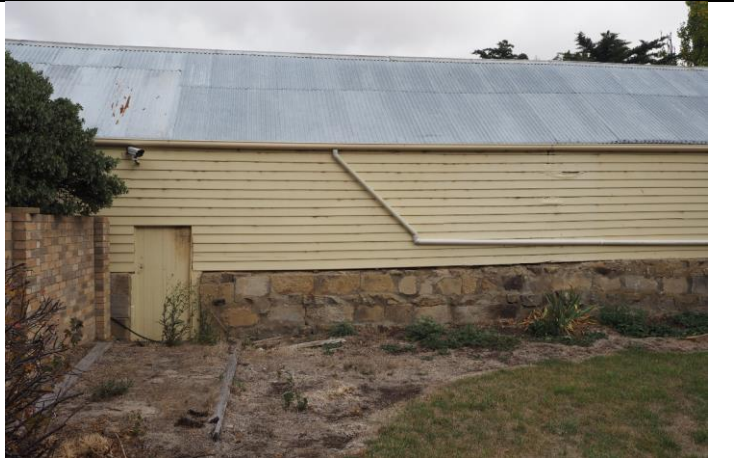
<p>Photo – Nest Property.</p>
Northern elevation	<p>The northern elevation of the stables is generally blank, with only a single pedestrian-sized door. The base of the building is roughly cut and laid sandstone block, which is probably from a building demolished and recycled into this building at the time of construction. The upper portion of the walls are weatherboard.</p>

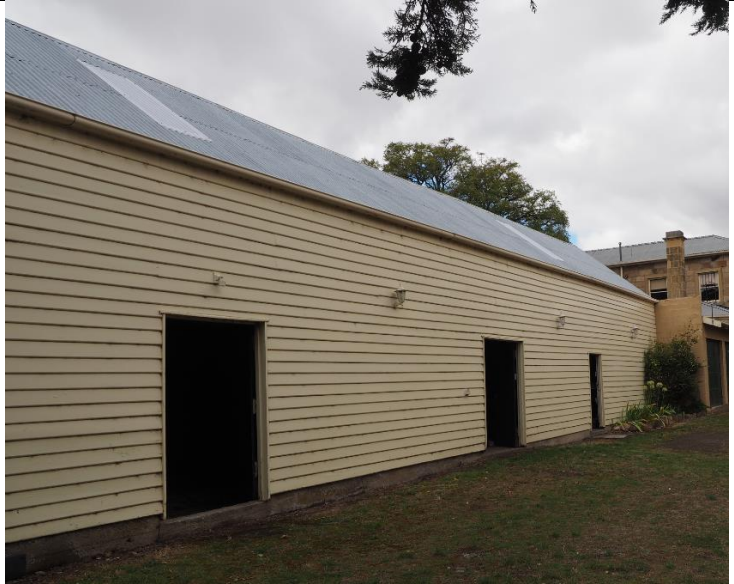
<p>Southern elevation</p>	<p>The southern elevation is the main face of the stables building, with two pedestrian sided doors as well as two double doors and a large opening into an open bay. The doors are timber ledger-and-brace style and the walls are clad in weatherboards. There are no windows on this elevation.</p>

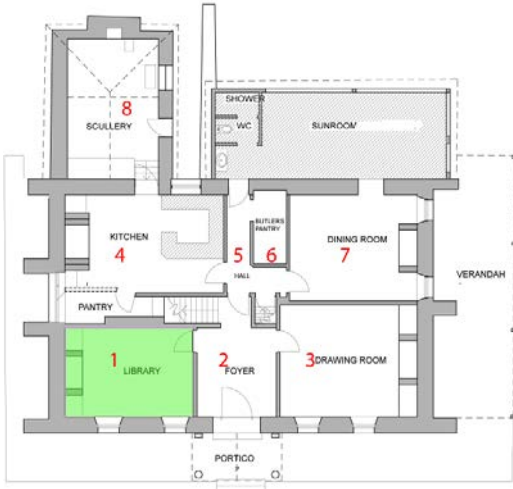
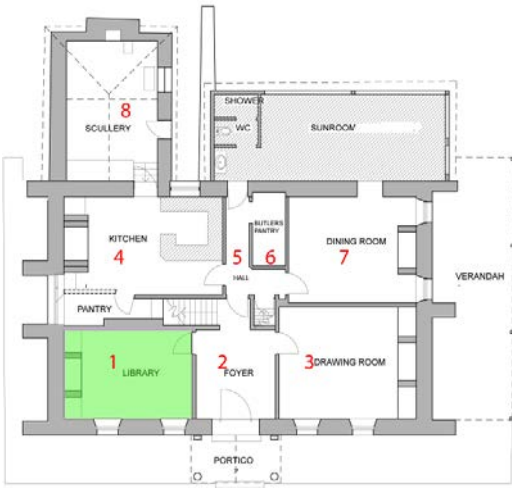
Room	Description, history and integrity	
1. Library	<p>The library is in its original form accessed off the front foyer. The room features a fireplace and two shuttered windows to the east. The room has its original Tas-oak flooring, plaster ceiling with ornate cornice and rendered plaster walls. There is evidence of an early green paint on the walls. This room features very high-quality cedar joinery, with a mantle, fluted columns to the edges of the chimney breast, two inbuilt cedar chiffonieres, cedar dado, cedar shutters, architraves, skirtings, cedar door with most of its original hardware and a very well-crafted gothic style inbuilt bookcase. All joinery retains an early shellac finish.</p>

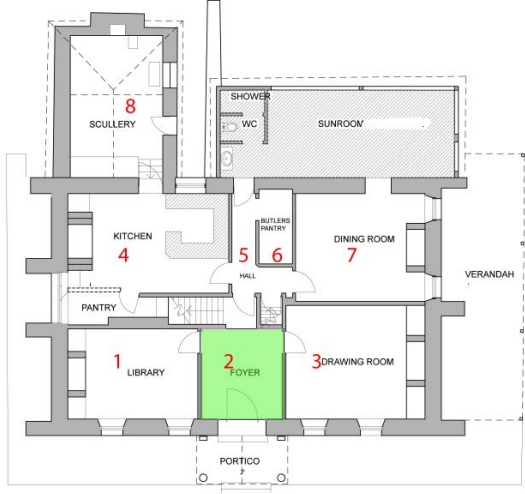
Room	Description, history and integrity	
2. Downstairs foyer	<p>The downstairs foyer occupies the central portion of the front elevation of the house. The foyer leads to the stairs which run to a 90-degree angle to the room as well as having a cupboard above the headspace to the cellar stairs which are accessed from the rear downstairs foyer. The room has its original Tas-oak flooring, plaster ceiling and ornate cornice and rendered plaster walls. The joinery is probably all cedar (except the stairs which appear to be Tas-oak) which has been painted multiple times but with a poorly executed and estapoled woodgrain finish on top. The joinery is ornate, with fluted columns beneath an arch to the ante-area of the foyer and to the door leading to back of house.</p> <p>The front door is set into a bulkhead and has rendered panels beneath the sidelights (an unusual feature).</p>

<p>A detailed floor plan of a house. The rooms are numbered as follows: 1. LIBRARY, 2. FOYER (highlighted in green), 3. DRAWING ROOM, 4. KITCHEN, 5. HALL, 6. BUTLERS PANTRY, 7. DINING ROOM, 8. SCULLERY. Other areas include PANTRY, SHOWER, WC, SUNROOM, and VERANDAH. A PORTICO is shown at the front entrance.</p>

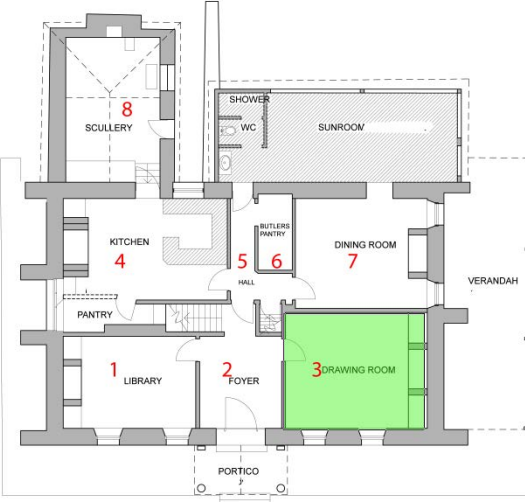
<p>3. Drawing Room</p>	<p>The drawing room is in its original form accessed off the front foyer. The room features a fireplace and two shuttered windows to the east. The room has its original Tas-oak floor and rendered plaster walls. The ceiling is pressed tin which has replaced the original ceiling and there is no visible evidence of a cornice (although further investigation may reveal such evidence. There is evidence of an early yellow paint on the walls.</p> <p>This room features cedar joinery, with two inbuilt cedar chiffonieres, cedar shutters, architraves, skirtings, and a cedar door with most of its original hardware. The mantelpiece is modern (fibreglass) and of a style inappropriate to the building. All joinery retains an early shellac finish, however some of this has been estapoled and some is quite degraded.</p>

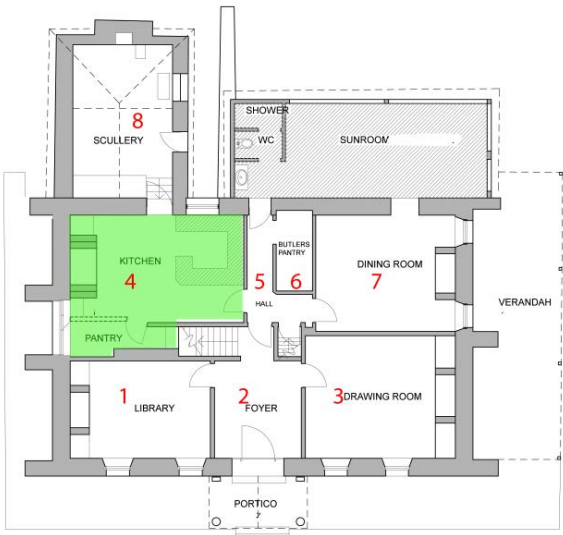
Room	Description, history and integrity	
<p>4.</p> <p>Kitchen and pantry</p>	<p>The evolution of the form of the kitchen is difficult to read, given that there have been a number of accretions and modifications – some quite early. The squareness and symmetry of the room is interrupted by partition wall to accommodate the stairs and the form of the room allows for passage through to the scullery – which is probably contemporary given the off-centring of the kitchen window resulting from the scullery wing. A pantry has been partitioned off from the main room via a very awkward partition behind the stairs that intercepts the end window, however this appears to be a very early addition given the door joinery, dado panelling and pit-sawn timber in its construction. The fact that the partition wall forming this pantry intercepts the centre of a window is odd. That pantry also includes a very early meatsafe.</p> <p>The floor appears to be the original Tas-oak boards (mostly covered by vinyl boards) and the ceiling and walls have all been re-plastered and an ornate cornice added. The large fireplace has a brick front added and there is an early cedar cupboard in the corner next to the fireplace.</p> <p>There appears to be little original/early joinery remaining apart from doors and door frames, however architraves and skirting boards may be obscured by modern linings (further investigation required). Removal of some of the modern panelling reveals a dado, which suggests that this room <i>may</i> have originally been a dining room (the dado and a possibly removed chair-rail typical of such rooms).</p> <p>Further analysis of this room is required once modern accretions are stripped.</p>

<p>The floor plan illustrates the layout of the house. Room 4, the Kitchen, is highlighted in green and is located in the center-left. It is connected to a central hall (5). To the left of the hall are the Library (1) and Foyer (2). To the right are the Drawing Room (3) and Dining Room (7). Behind the hall is the Butlers' Pantry (6) and the Scullery (8). The Scullery is connected to the Kitchen and has a window that is off-centred. A Shower and WC are located near the Sunroom, which is adjacent to the Scullery. A Verandah and Portico are also shown.</p>

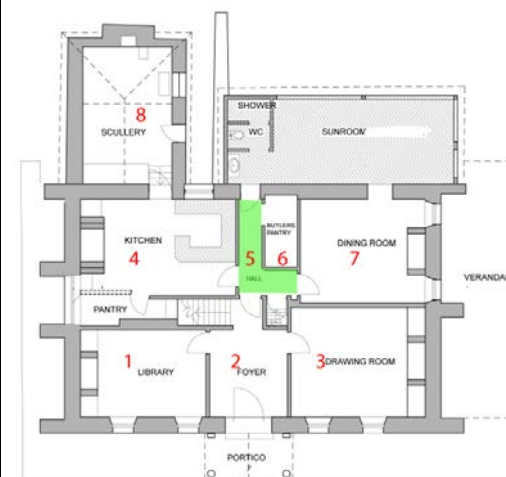
Room	Description, history and integrity	
<p>5. Downstairs rear hallway</p>	<p>The downstairs hallway is an 'L' shape leading from the back door to the front foyer and along at a right angle to the dining room. The butler's pantry is a small room to the side of the foyer which has been reduced to around half its original size to enlarge the dining room. The basement leads off the junction of the two sections of this foyer/hallway.</p> <p>The hallway retains most of its original joinery, although there appears to have been some modification around the back door (this door has been replaced and modified) and around the door to the dining room (which would have been modified when the dining room was enlarged. The joinery (except for the door frame/architraves) of the butler's pantry has been modified – presumably at the time that room was reduced in size and shelving has been added. The pantry door has been replaced with a curtain and back door has been replaced – all other doors appear to be original (note that the frame of the dining room door has been replaced presumably when that wall was realigned).</p> <p>The room retains its original wide Tas-oak flooring. The hallway ceiling has been battened and plaster sheeted with a modern cornice, however the butler's pantry appears to retain its original plaster ceiling. All walls are rendered plaster (except the northern wall of the butler's pantry where the size of that room has been reduced.</p>

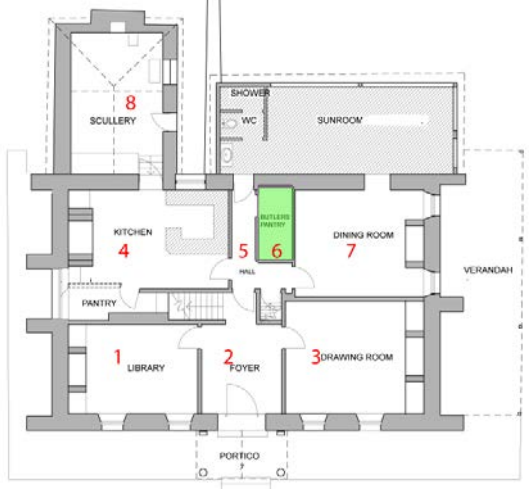
<p>6. Butler's Pantry</p>	<p>The butler's pantry is a small room to the side of the foyer which has been reduced to around half its original size to enlarge the dining room. The joinery (except for the door frame/architraves) of the butler's pantry has been modified – presumably at the time that room was reduced in size and shelving has been added. The pantry door has been replaced with a curtain and back door has been replaced.</p> <p>This room retains its original wide Tas-oak flooring and original paster ceiling. All walls are rendered plaster (except the northern wall of the butler's pantry where the size of that room has been reduced).</p>

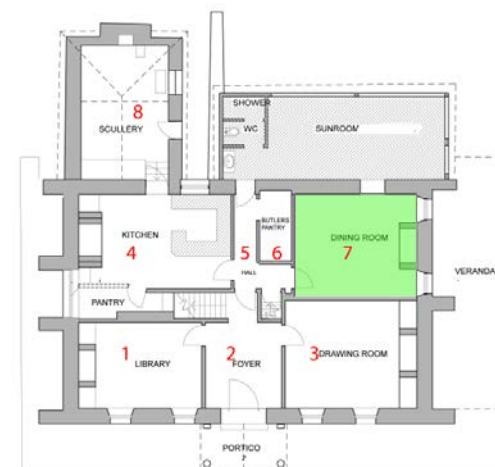
Room	Description, history and integrity	
7. Dining room	<p>This room has been reconfigured to make a larger room by realigning the wall of the butler's pantry and making that room smaller – evidence of the removed all can still be felt through the wallpaper and this would align with the wall between the two bedrooms upstairs. . Originally, this room would have had no windows on the northern side (i.e. the current windows on either side of the fireplace) and would have had a single window in what would have been the centre of the western wall (now converted to a door to the sunroom).</p> <p>The detailing in this room has been almost wholly altered, with a more recent floor and ceiling, and all joinery (except the door to the hall which is probably the original door in a new location) has been replaced in c1950s style profile. The original chimney breast remains which has had a sandstone front added and the size of the firebox reduced. The walls have been wallpapered however the original rendered plaster is likely to remain beneath (note that the wall between this room and the butler's pantry is new.)</p>

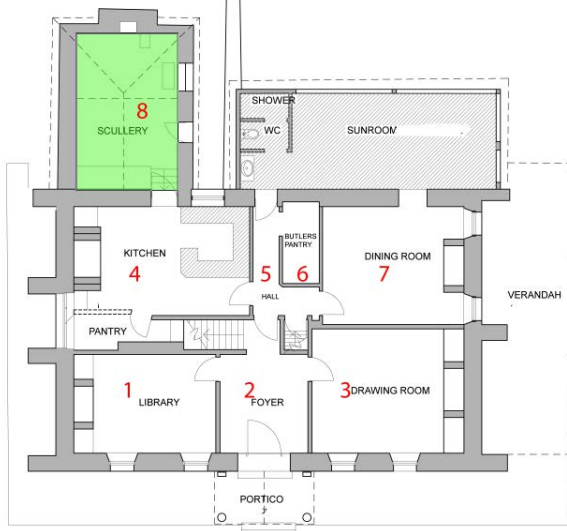
Room	Description, history and integrity	
8. Scullery	<p>The scullery is contained in a rear wing of the house which is probably contemporary with the main portion of the house and is likely to have been the original kitchen. A single room with a raked ceiling, it is entered both from outside as well as from the current kitchen. It has a single window to the north (of odd proportions, but seemingly original) and a large fireplace (bricked up) to the western end. The entire room was until recently completely lined in Masonite on a studded wall – removal of this has revealed the original rendered masonry walls and limewashed underside of the shingled roof.</p> <p>The floor has been replaced with modern Tas-oak tongue and groove boards, the original hearth has been removed or covered, and there is no evidence of any original joinery remaining (apart from the door frame to the kitchen) although the wall with the window and external door is yet to be stripped of modern linings.</p>

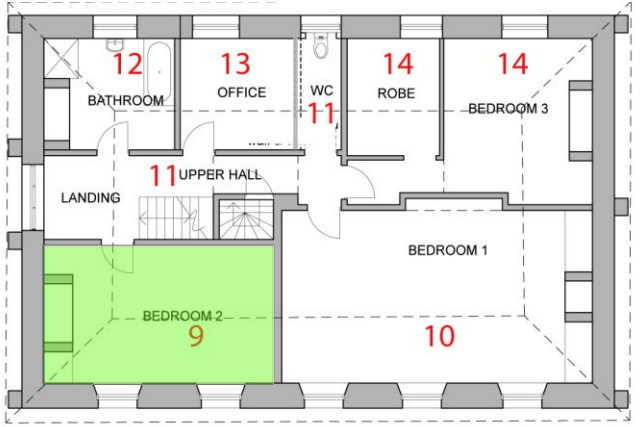
Room	Description, history and integrity	
9. Bedroom 2	<p>This room retains its original form and is accessed from the top of the stairs. The room has a fireplace and two east facing windows.</p> <p>The room largely retains its original joinery, however the mantelpiece appears to have been replaced with a sympathetic reproduction. There are two cupboards which are early if not original on either side of the chimney breast (note that the cupboard closest to the front of the building has had doors added to what would have been open shelves).</p> <p>The floor and wall linings appear to be wholly original and the ceiling has been sheet plastered presumably over the original lathe and plaster. The room has been wallpapered in recent years and a woodheater has been installed in the fireplace.</p>

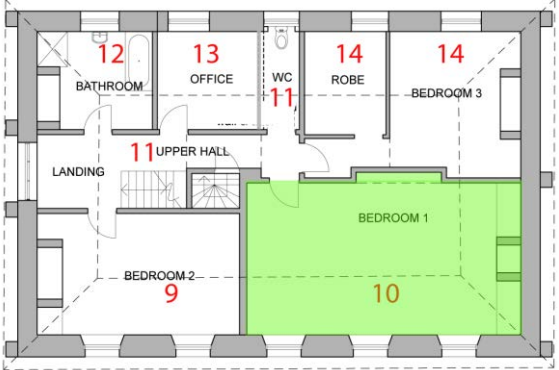
Room	Description, history and integrity	
10. Bedroom 1	<p>This is an unusually large room which suggests its original function was more as a ballroom or other formal room. Accessed from the upper hallway, the room retains its original form an all detailing is slightly more ‘grand’ than the other upstairs rooms. The room has three east facing windows and a fireplace. All original architraves and skirting boards remain and these are more detailed than elsewhere on the upper floor (i.e. wider skirtings and panelled window reveals).</p> <p>The room retains its original wide Tas-oak flooring and all wall linings appear to be the original rendered plaster (wallpapered). The ceiling has been replaced with pressed tin probably in the first half of the twentieth century. There is a wide arched wall niche on the western side of the room and a more recent cupboard (c1940s) on each side of the fireplace. The original cedar mantlepice remains and a woodheater has been installed in the fireplace.</p>

A detailed floor plan of the upper floor of a building. The plan shows several rooms: a Bathroom (12), an Office (13), a WC (11), a Robe (14), and three Bedrooms (9, 10, and 14). Bedroom 1 (10) is highlighted in green. It is a large room with a fireplace on the western side and a wide arched wall niche. The room is accessed from the upper hallway (11) via a landing. The plan also shows a Landing (11) and a Landing (12). The rooms are numbered in red, except for Bedroom 1 which is highlighted in green.

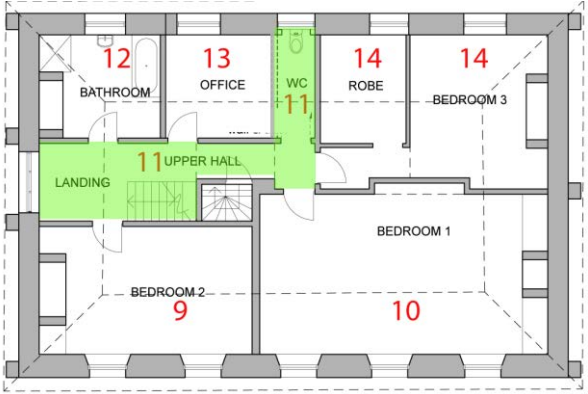
Room	Description, history and integrity	
11. Upstairs hallway and WC	<p>This room was formerly a L-shaped hallway leading from the stairs landing through what is now the WC which has had a partition and door added. A staff bead on what would have originally been an external corner where the hallway turned. There was originally a door leading from the rearward hallway (now partially infilled and with a toilet in front). The room has a large window to the southern end which is disproportionate to the remainder of the windows in the building, however appears to be early/original.</p> <p>The hallway leads to five principal rooms as well as the stairway to the attic rooms.</p> <p>The original wide Tas-oak floorboards remain as do the rendered plaster wall linings (now wallpapered). The ceiling has been plaster sheeted and removal of the modern coved cornice has revealed part of an earlier cornice which has mostly been removed. Note that the ceiling height in the hallway, bathroom, office, WC and robe are all lower than the remainder of the upstairs rooms to accommodate the attic spaces.</p> <p>The central section of the hallway has a vaulted arch section which corresponds to the attic stairs.</p>

11. Upper hall				
Element	General significance	Elements of higher significance	Elements of lower significance	Note
Form			Broken form to include toilet	
Floor				
Walls				
Ceiling		The arched ceiling section is of very high significance.	Plastersheet false ceiling	Remnants of cornice are of high significance but are incomplete
Joinery			Door to toilet and associated joinery.	
Stairs, railings etc.				
Toilet and associated bathroom fitout

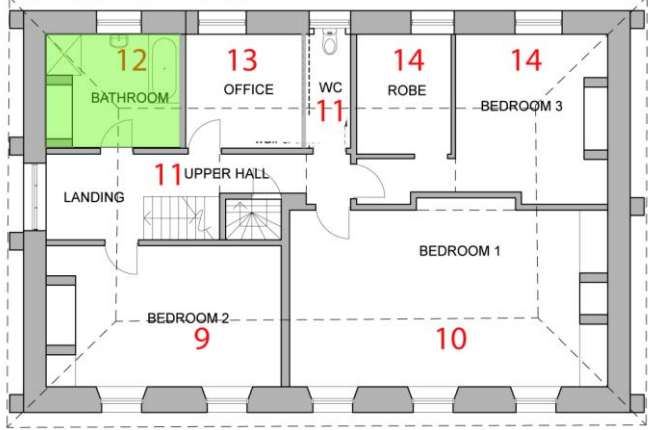
Room	Description, history and integrity	
12. Bathroom	<p>This room retains its original form accessed from the top of the stairs and has a fireplace and single window to the west. Little can be seen of the earlier detailing of the room as it has been fitted as a bathroom, the walls tiled, has a vinyl floor and the ceiling has been sheet plastered presumably over the original lathe and plaster. The upper portion of the walls appear to be the original plaster as evidenced by a staff bead on the edge of the fireplace. The fireplace has been boarded up and a cupboard installed on the face – the mantle has been removed.</p> <p>The window reveals have been re-lined with modern ply panelling and it is unclear whether any other window joinery or skirting boards remain. The original door and architraves/doorframe remain.</p>

12. Bathroom				
Element	General significance	Elements of higher significance	Elements of lower significance	Note
Form				
Floor				
Walls				Likely to be very damaged.
Ceiling			Plastersheet	
Joinery

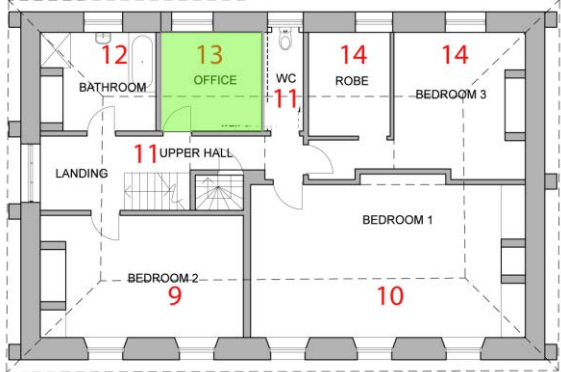
13. Office	<p>This room retains its original form and is accessed off the upstairs hallway and has a single west facing window. The room does not have a fireplace although is of a comparable size to room 11. This room appears to retain all original joinery of a very plain style which has been recently woodgrained. The window reveals appear to be more recent and may be contemporary with the replacement of the windows as discussed elsewhere.</p> <p>The room retains its original wide Tas-oak floorboards and plastered walls. The ceiling has been sheet plastered presumably over the original lathe and plaster.</p>		
	Selected Images

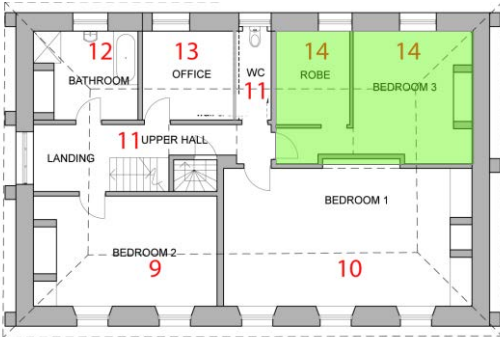
Room	Description, history and integrity	
14. Bedroom and robe	<p>The arrangement of this room is odd and it appears that a corner has been cut off the room for a robe, the wall of which oddly abuts the window reveal which has been splayed in the opposite direction to expected to accommodate this. The presence of this smaller room necessitates a small passageway to enter the main room. However, closer inspection of that partition wall indicates that it is original as the plaster is on split lathe, there are hand-made nails in the lathe and the framing is integral to the floor framing (and the floorboards do not run all the way through. The alignment of this wall also corresponds with the edge of the attic wall and the now removed wall once between the dining room and butler’s pantry. The planning of this room is further confused by the rear of the arched niche of the room in front which butts into the room as well as differential ceiling heights resulting from part of this area being beneath the attic rooms.</p> <p>These rooms retain practically all of their original joinery (note that the architraves on the bedroom side of the doors are modern), which is also much plainer than that of the front rooms despite this room being a larger size – although the original cedar mantelpiece is on a similar scale of grandeur to the principal rooms. It is unclear whether the window reveals are more recent and may have been modified at the time of the insertion of the new windows. The walls and ceiling have sheet plastered presumably over the original lime render and lathe and plaster.</p>
