Demolition, Alterations & Additions, Change of Use Barn to Visitor Accommodation

DA 2020 / 00079

Planning Permit Application for alterations and additions

ALTERATION & ADDITIONS - 'Strathborough' - 2120 Hollow Tree Road, Hollow Tree, Tasmania

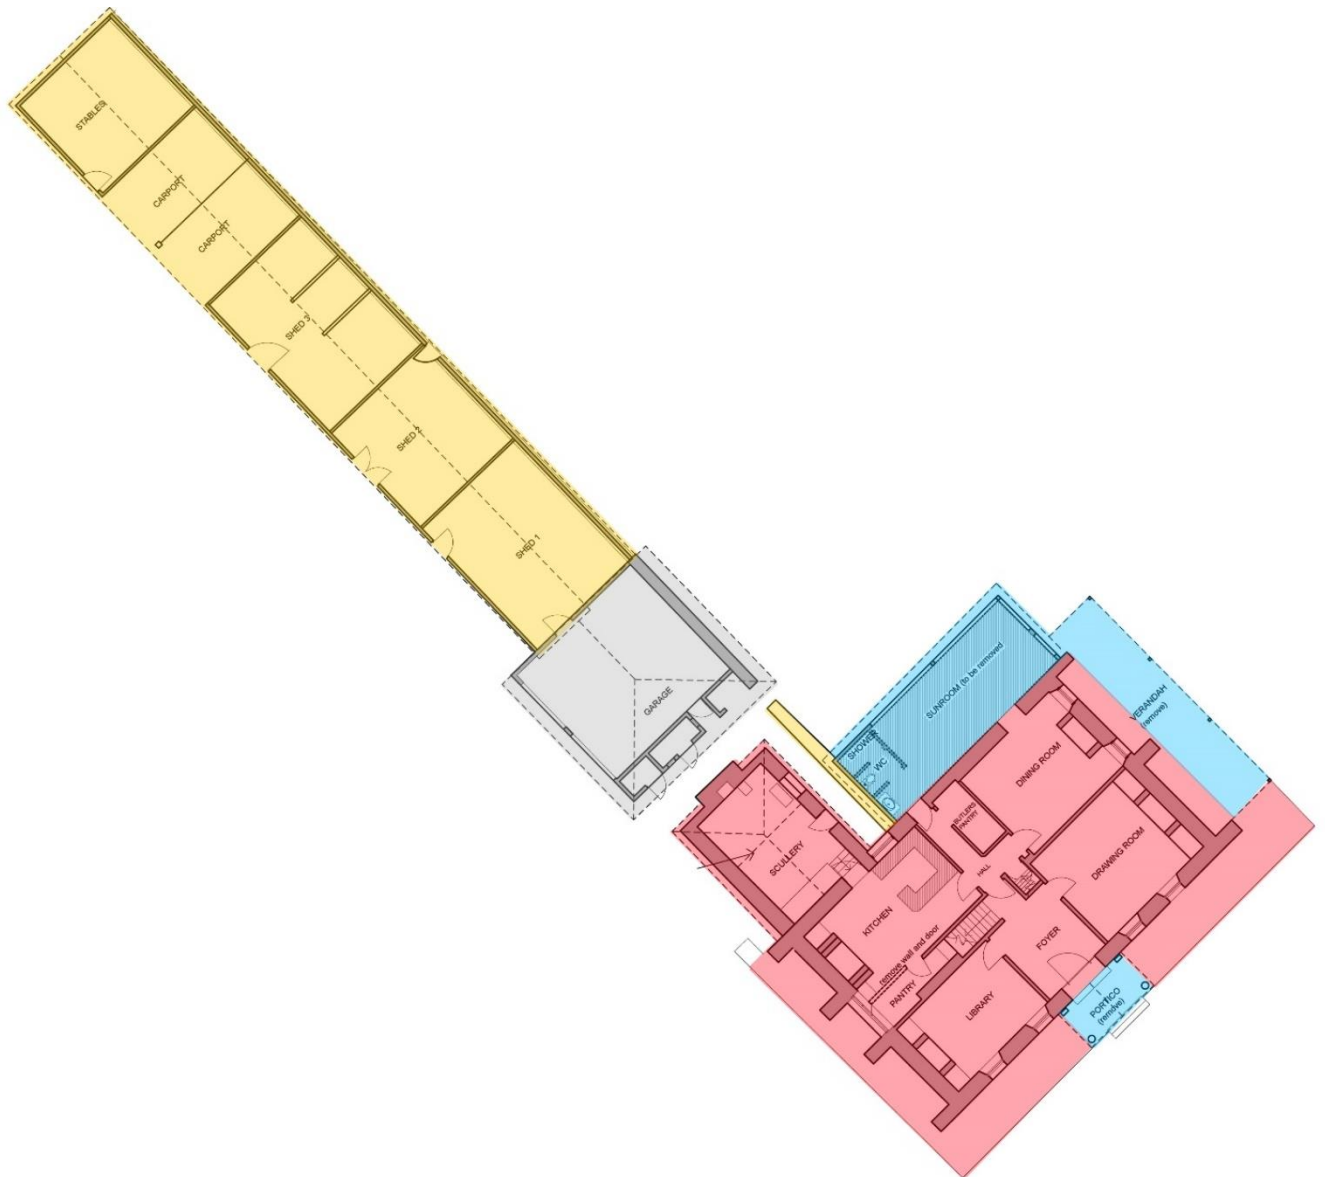
Figure 7.1 – Broad areas of the building as introduced Section 3.

Colour as per Fig. 7.1.	Portion of the building	Circa	Significance
Red	Main body of homestead, including scullery	1827-1832	High
Orange	Stables and garden wall	c1900	Medium
Blue	Sunroom, veranda, portico (note that the stone floor of the veranda and portico is of high significance)	cmidC20th+	Intrusive
Grey	Garage	c1980s	Neutral

Based on the historical overview of site development as per Section 3, the fabric analysis of Section 5 and the statements of historic heritage significance detailed in Section 6, the following summary of significance of broad areas of the building is provided.

As per Section 7.2, it is concluded that only the original footprint of the Strathborough building is the only built element of the site with a medium or high level of significance. Section 3 has detailed the various eras of renovation of that building, with modifications in some cases having been extensive. Figures 7.1-7.2 depict the areas of broad integrity as can be alluded form the knowledge of the various renovations.
